HVE-WP-2018-2

Three Vehicle Chain Reaction Collision Injures an NHL Hockey Player

Thomas Jenkyn, PhD PEng
TLS Biomechanics & Engineering
London, ON, CANADA

Reprinted From: 2018 HVE Forum White Paper Session

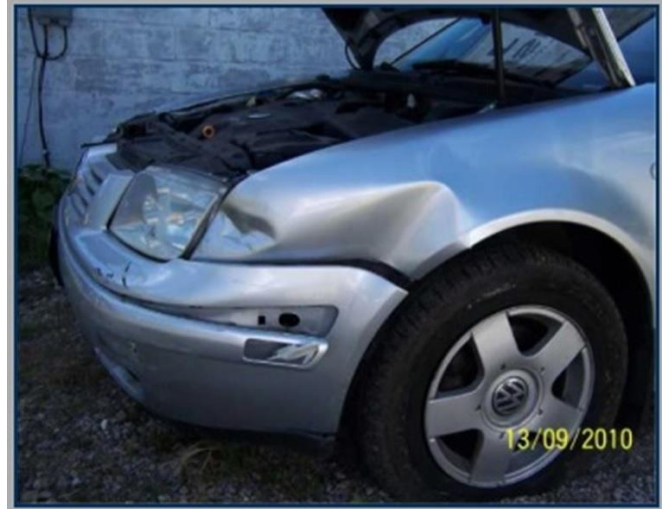
Photographic evidence of the damage to the plaintiff vehicle (V1) was provided. The primary impact occurred on the front left bumper and the front left quarter panel (Figure 3). The bumper cover was badly scratched and scored. The overall bumper cover was grossly moved out of alignment. The trim on the front left headlight and the orange indicator light were both damaged and moved out of their proper positions (Figure 3). The alignment of the left and right front quarter panels is deformed with respect to the hood and the hood will no longer line up at its left and right sides. With the front bumper cover removed, the front impact bar can be seen to be grossly intact. However, it is not possible to determine whether the left and right brackets that hold the impact bar to the chassis are intact or are deformed and compressed (Figure 4).

Figure 3: A left front view of the 2002 Volkswagen Jetta (V1).

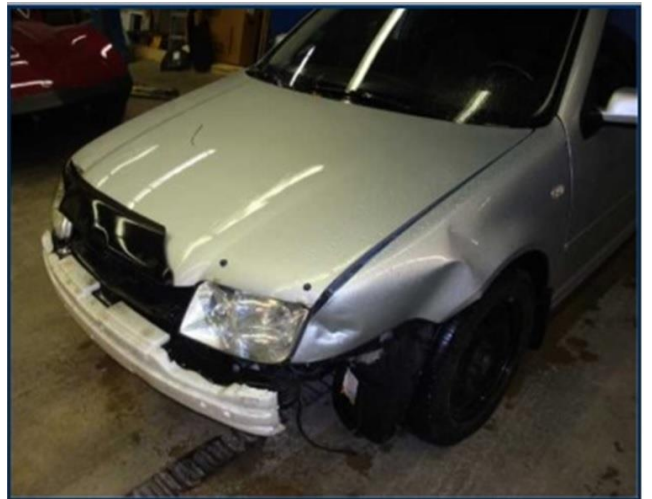
Figure 4: A view of the left front of the Volkswagen Jetta (V1) with the front bumper cover removed.

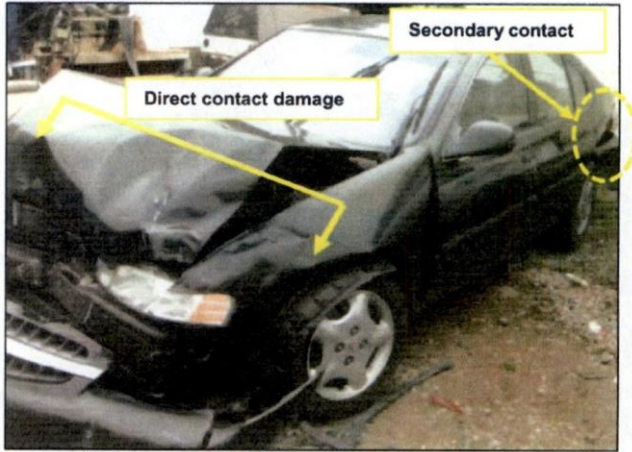
Figure 5: A view of the left front of the Nissan Altima (V3) showing primary and secondary contact damage.

The simulated collision deformation classification for V3 was `01RFEW3` which corresponds to an impact from the right front in a wide area over the front quarter with a significant amount of penetration into the structure of the vehicle. The amount of penetrating crush was simulated to be 18.9 cm. This is consistent with the physical damage in the photograph in Figure 5 showing approximately this amount of penetration into the structure of the Nissan. The direction of the force and the location of the impact are consistent with the collision.

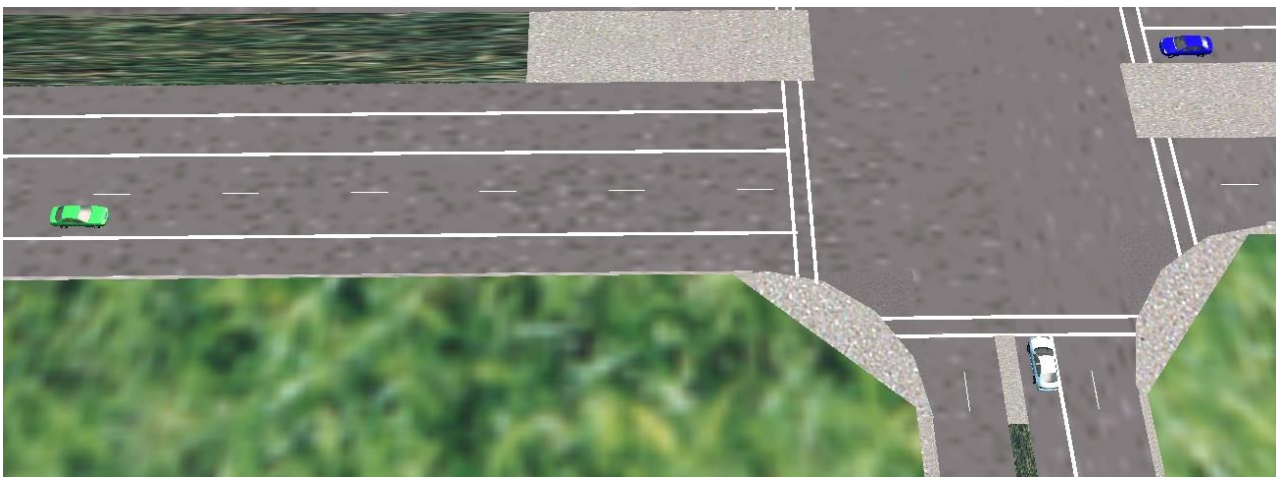
Within the HVE simulation an environment was created that represented the location of the collision at Highway 6 and Kortright Road. This is shown in Figure 6. The relative positions of the lanes with V1, V2 and V3 are correct. Details that were not relevant to the accident were simplified, such as the exact shapes of the medians. The

Figure 6: Representation of Highway 6 and Kortright Road in HVE environment. North is to the right as in Figure 1. The relative positions of the lanes for V1, V2 and V3 are correct if some details have been simplified.

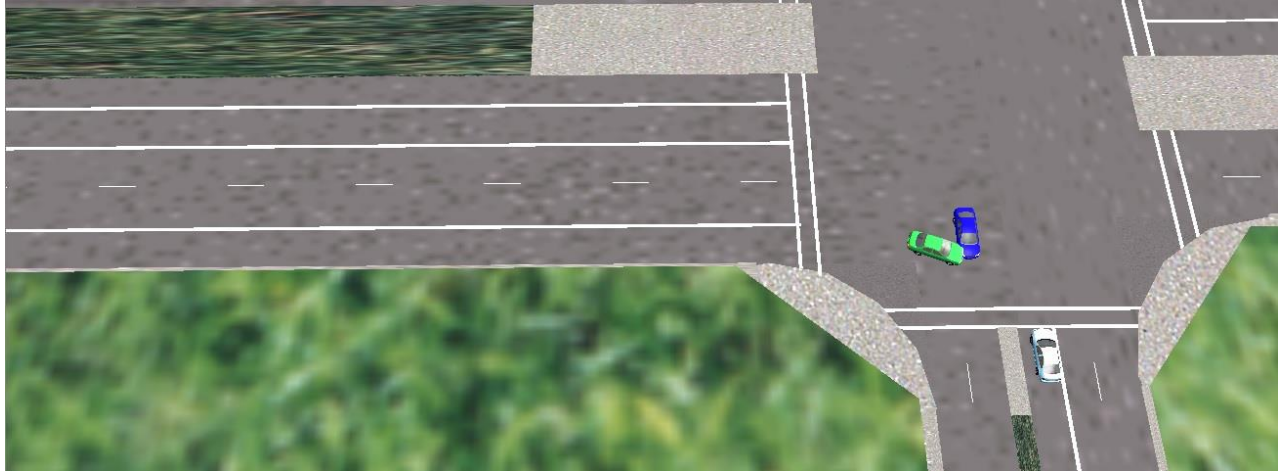
- At time 4.14s V3 and V2 collide. The front right corner of V2 hits the front left side of V3 (Figure 7). The two vehicles separate at 4.59s, but V3 is now headed toward the stationary V1.

Figure 7: Initial collision between V2 (blue car) and V3 (green car) occurs at $t=4.14s$. The vehicles separate at $t=4.59s$ but now V3 is headed toward V1 (plaintiff's white car).

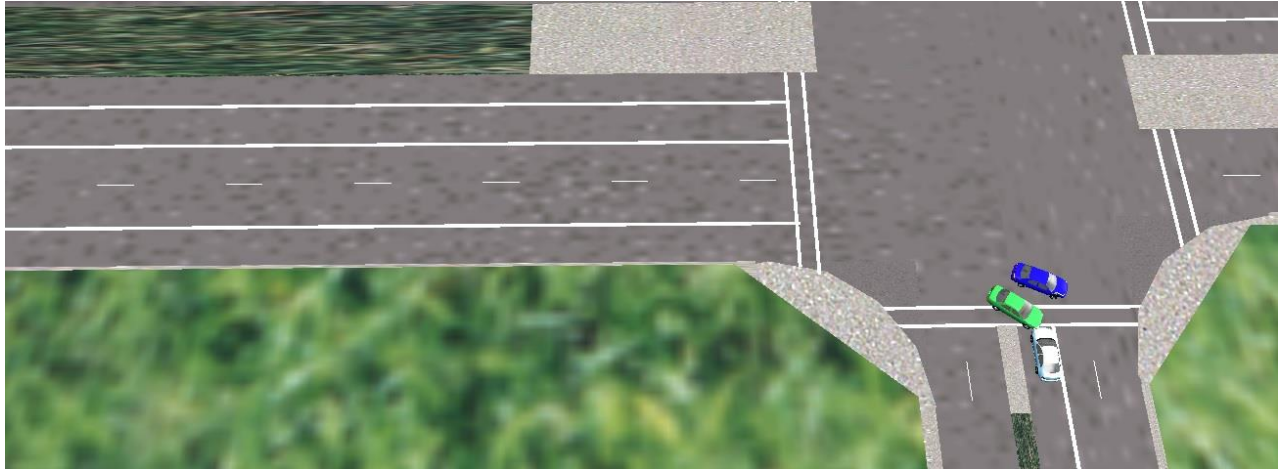
- V3 strikes V1 at 4.91s into the simulation. The front right of V3 strikes the front left of V1 (Figure 8). The vehicles separate at 5.03s.

In the example simulation, the collision deformation classification for the plaintiff's Volkswagen Jetta (V1) was `11FYEN1` which corresponds to an impact from the front left side with a small amount of penetration into the structure of the vehicle. The amount of penetrating crush of the bumper was simulated to be 5.7 cm. This was consistent with the physical evidence shown in the photographs in Figures 3 and 4. So, this damage profile should conservatively estimate the force applied to the V1 during the collision with V3, the Nissan Altima. The direction of the force and the location of the impact were consistent with the collision.

Figure 8: The second collision occurs between V3 (green car) and V1 (white car) at $t=4.91s$ and separation at $t=5.03s$.

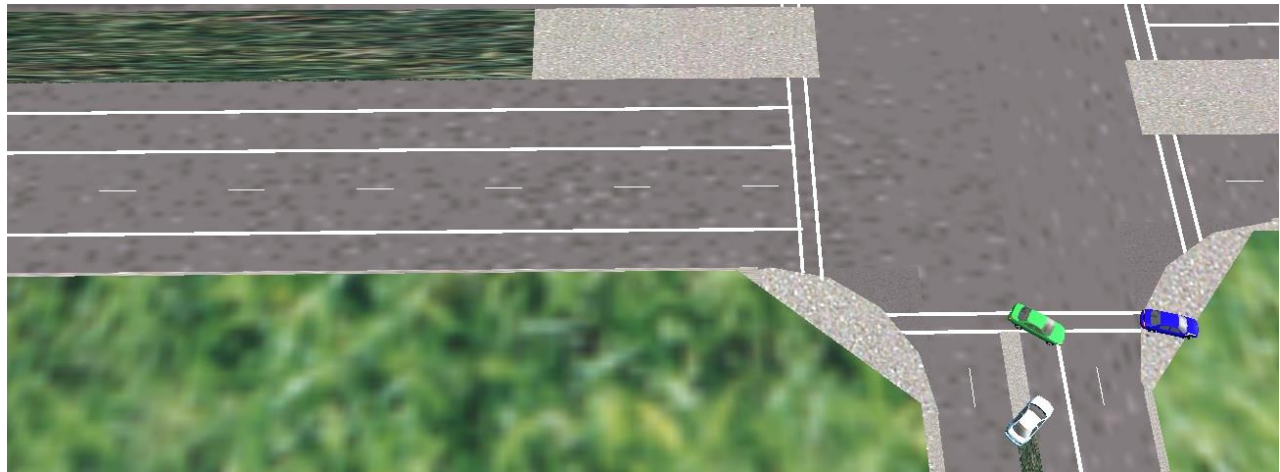
- V1 is sent backward by the force of the second collision and rotates in a clockwise direction, coming to rest on the median of Kortright Road West (Figure 9).

Figure 9: All vehicles come to rest by $t=8.16s$. V1 (white car) is pushed backwards and onto the median on Kortright Road, which is consistent with the physical evidence in the police report.

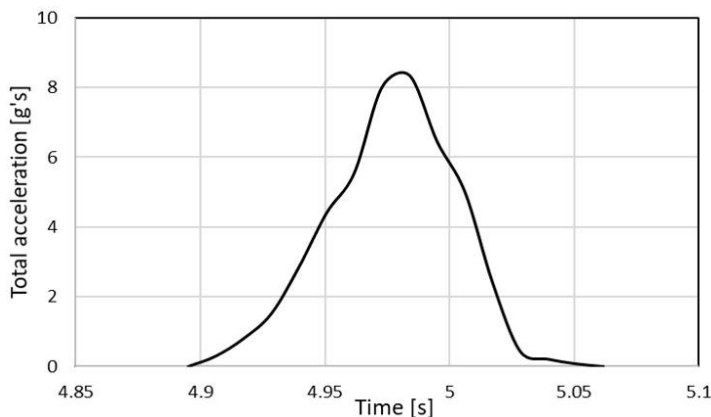
At the accelerometer, the maximum acceleration experienced during the second collision by the driver of V1 was 8.43 g's (Figure 10). This is above the threshold for injury at the neck of 8 g's (Ivancic et al, 2005). The NIC was calculated using the method of Funk et al (2011) to be 43.3 m²/s². This is also significantly greater than the threshold for injury at the neck reported in the literature, 17.9 m²/s² (Ivancic et al, 2005). It might be informative to note that the NIC and peak acceleration associated with sitting down rapidly onto a rigid wooden chair are NIC=5.5 m²/s² and a=3.7g respectively (Funk et al, 2011). The delta-v experienced by the occupant of the Jetta was simulated as 15.9 km/hr, or 4.4 m/s. This is greater than the minimum delta-v required to cause a concussion in the Viano study (Viano et al, 2007). Therefore, the simulated collision between V3 and the plaintiff's V1 was of sufficient severity to cause a whiplash injury (WAD2) injury to the neck with symptoms lasting longer than 6 months, and to cause a concussion.

Figure 10: Collision pulse experienced at the position of the virtual accelerometer.
