# Vehicle Trajectory Following Steering Disconnect Investigated by Application of HVE-VSM Steering DOF Capability

**William Blythe**  
Consulting Engineer

## ABSTRACT

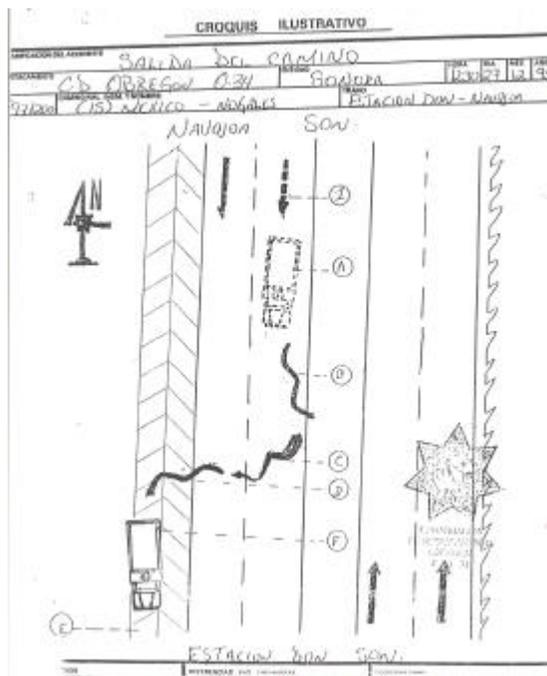
Figure One

This single vehicle accident occurred on Mexico Highway 15 near Obregon, in Sonora State. The accident was investigated by the Mexican Federal Police. The diagram from the police report is shown in Figure One. No measurements of the tire marks were included, and the tire mark indications were made with a rubber stamp.

were about twenty meters long and were "zig-zag" marks. He did not recall whether each tire mark indication stood for one or more marks.

Significant aspects of the tire marks were that they first went to the left, to the edge of the grass median, and then turned to the right to cross the lanes and exit the road on the right. The final rest of the vehicle was parallel to the road, as shown, but down a rather severe bank into an arroyo.

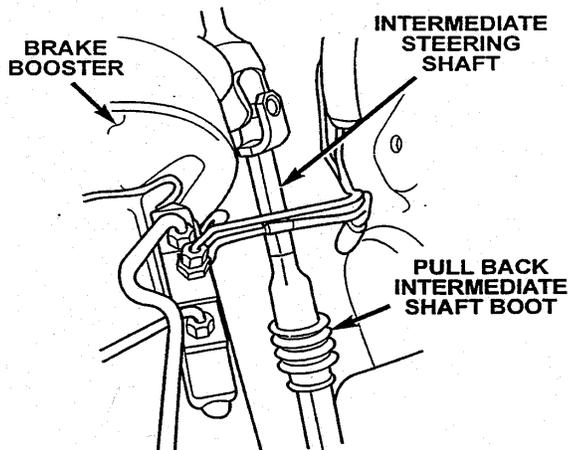
Figure Six

Chrysler Corporation issued Recall Notification No. 709 in January of 1997. The Recall indicated that if certain shaft internal retainers failed, the lower steering column could separate from the upper column, resulting in a total loss of steering control. This detail was part of the column collapse provision. A field fix involved placing a

plastic sleeve around part of the intermediate shaft (a part of the upper column), to prevent it from dropping into the lower column if the retainers failed. The first page of the Recall is shown in Figure Five and column diagrams are shown in Figures Six and Seven.

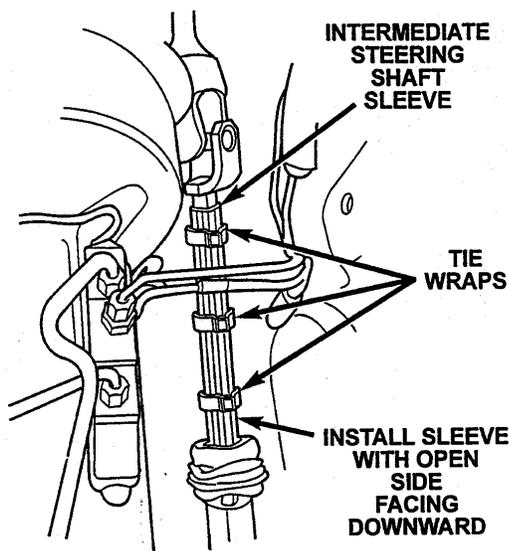
Figure Seven

The important fact of this potential failure was that it was neither intermittent nor partial; if it occurred, it was immediate and total. This allowed its simulation by the HVE-VSM steering DOF model.

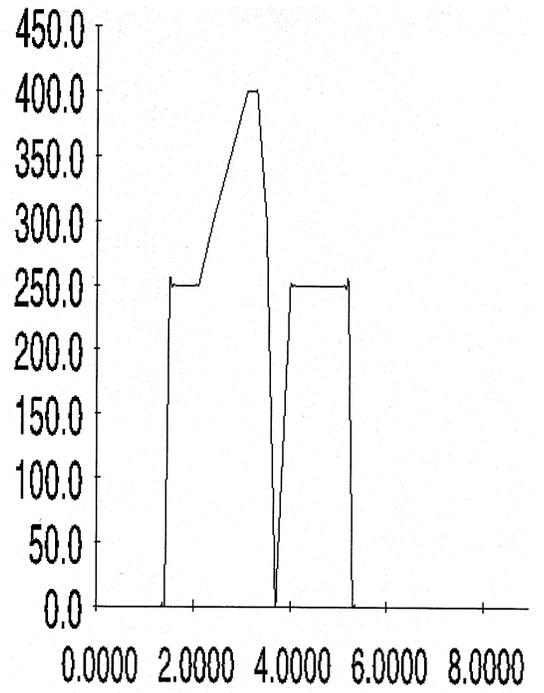
Figure Fifteen

The braking pattern for this particular run is shown in Figure Fifteen. The vertical scale is Newtons of brake pedal force.

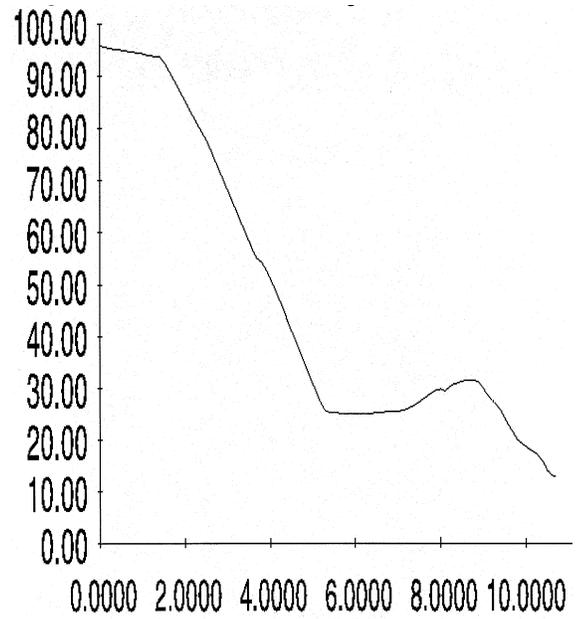
Figure Sixteen

Speed versus time is shown in Figure Sixteen; the vertical scale is kilometers per hour.

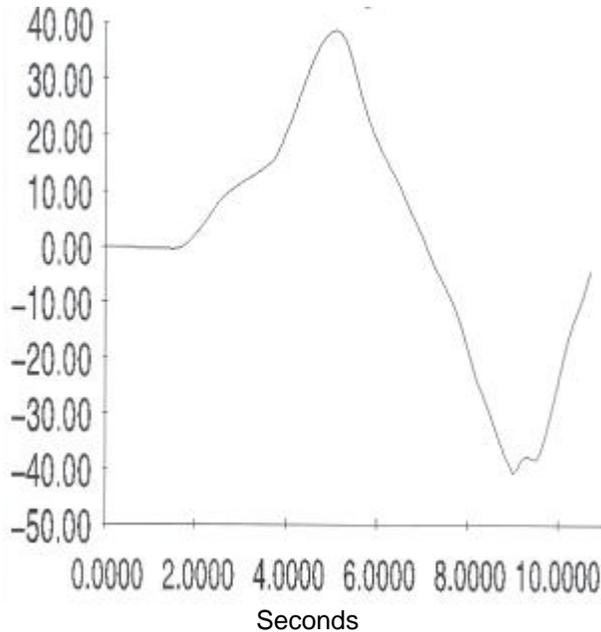
Figure Seventeen

Yaw (degrees) versus time is shown in Figure Seventeen.

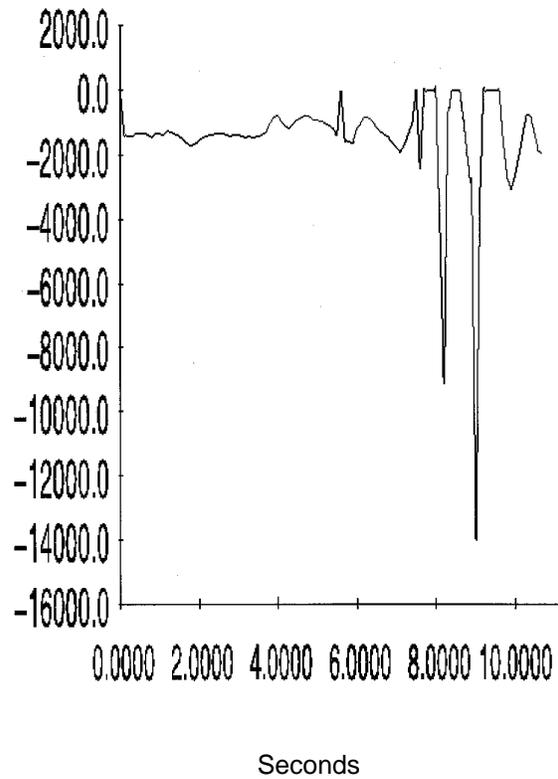
Figure Eighteen

Front tire vertical force is shown in Figure Eighteen. The vertical axis is in pounds. These loads seem consistent with the deairing of the tires, as reported by the investigating officer.

Although the off-the-road portion of the simulation was not expected to produce accurate, detailed results, the potential for very high tire loads was indicated, suggesting a possible explanation for the deaired front tires as found by the police officer.
