HVE CASE STUDY – EXAMPLE REPORT

Re: Your Ref - State v. John David
D/A - 11-4-91

Subject: Crash Reconstruction - Preliminary Report

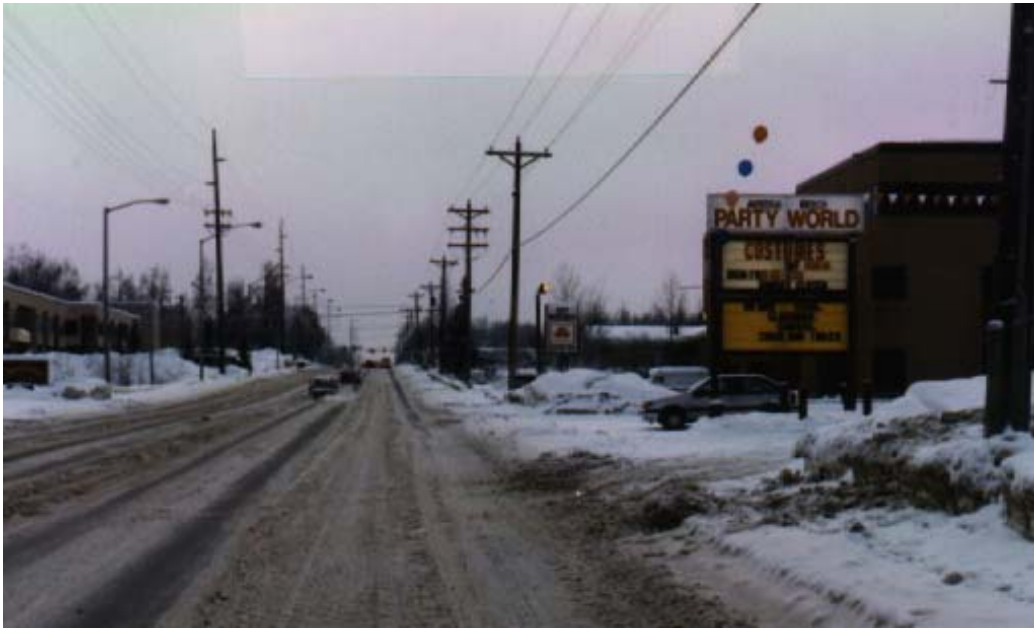
1. Inspection at the crash site revealed Arctic Boulevard was a 4-lane, undivided road, with two lanes northbound and two lanes southbound. Lane widths were 12 feet. The road was straight and level and had a 6-inch crown in the vicinity of the crash. The traveled lanes were bordered on each side by 6-foot wide sidewalks with 6-inch curbs. The surface of the traveled lanes was moderately-worn asphalt. See Figures 1 and 2.

Figure 1 - Accident site as inspected on January 4, 1992, 60 days following the crash. This view is looking southbound, the direction traveled by Mr. David.

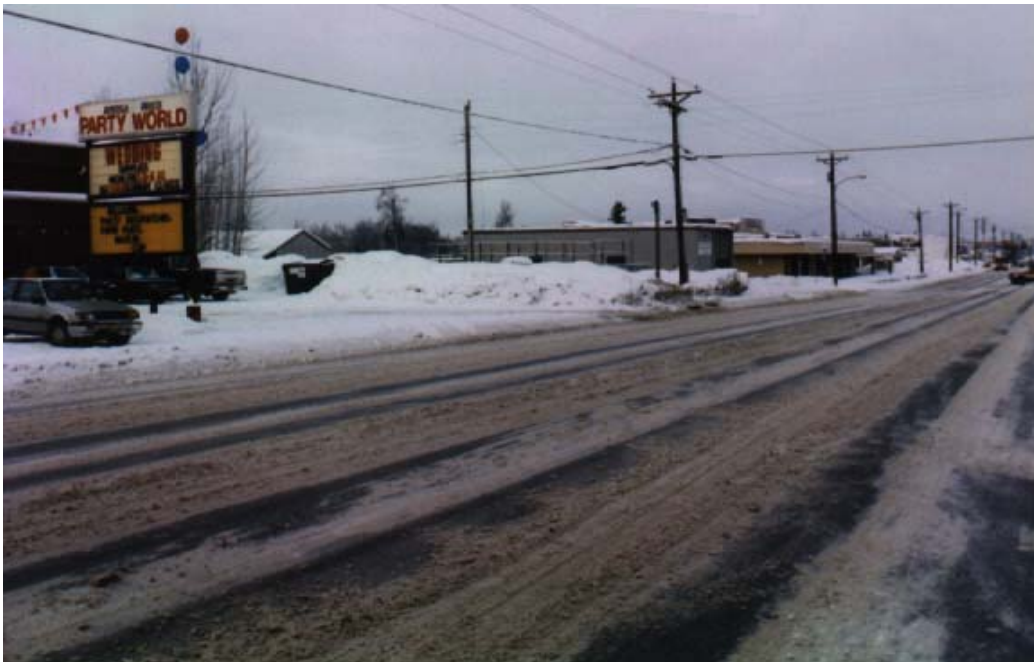
Figure 2 - Accident site as inspected on January 4, 1992, looking northbound.

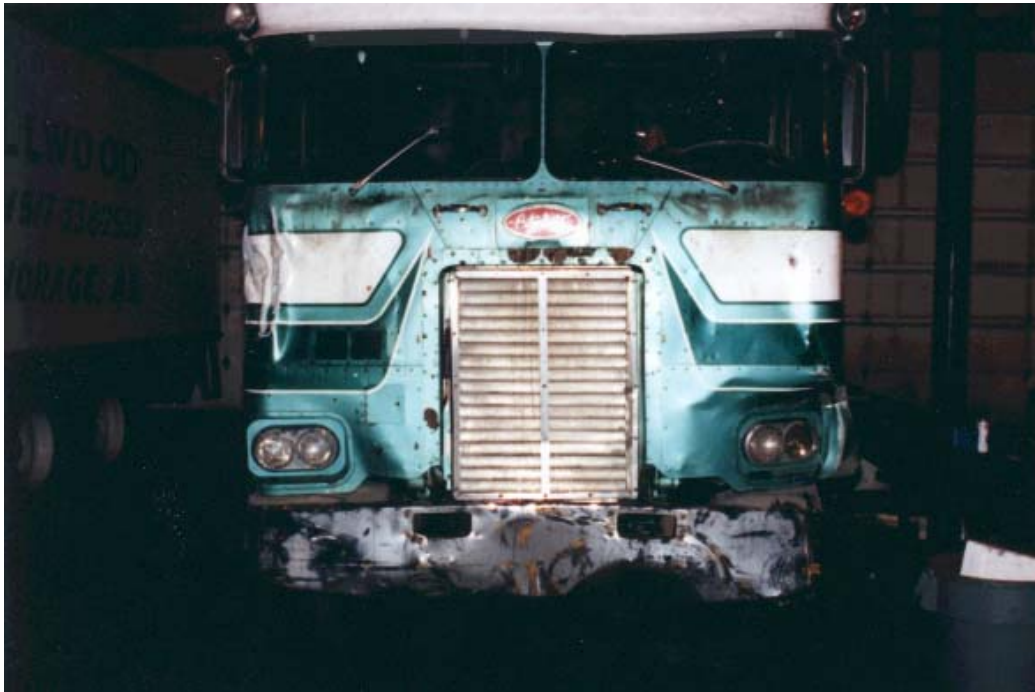
Figure 3 - Frontal view of 1975 Peterbilt tractor as inspected on January 5, 1992. Note the black, circular impression towards the left end of the bumper. This impression was caused by the Volkswagen's left front tire.

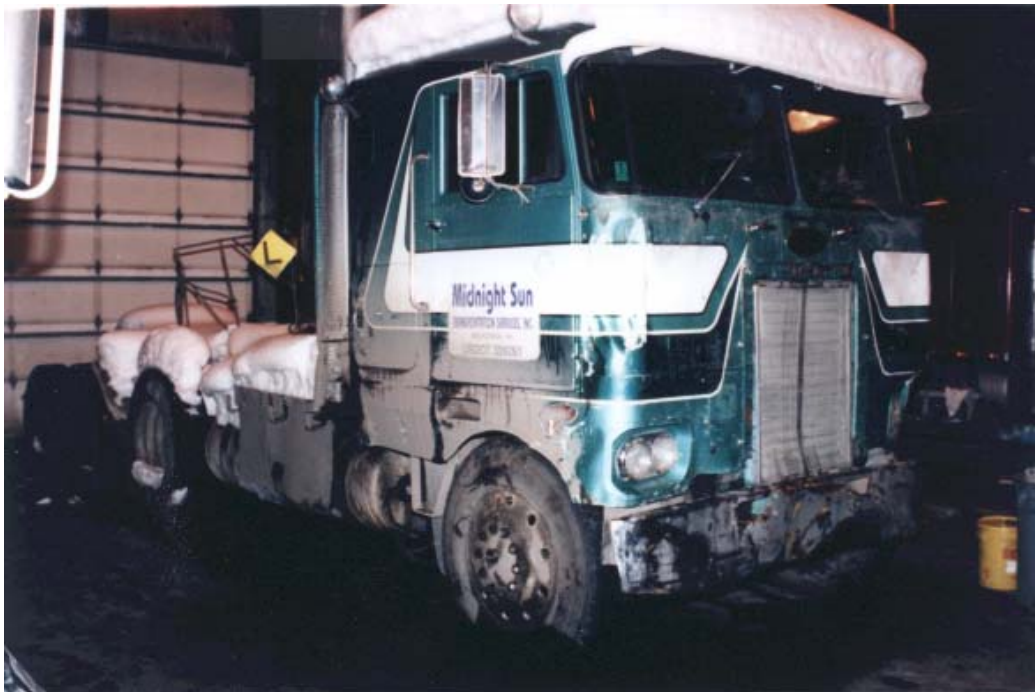
Figure 4 - Oblique view of 1975 Peterbilt tractor. Note the minor frontal damage.

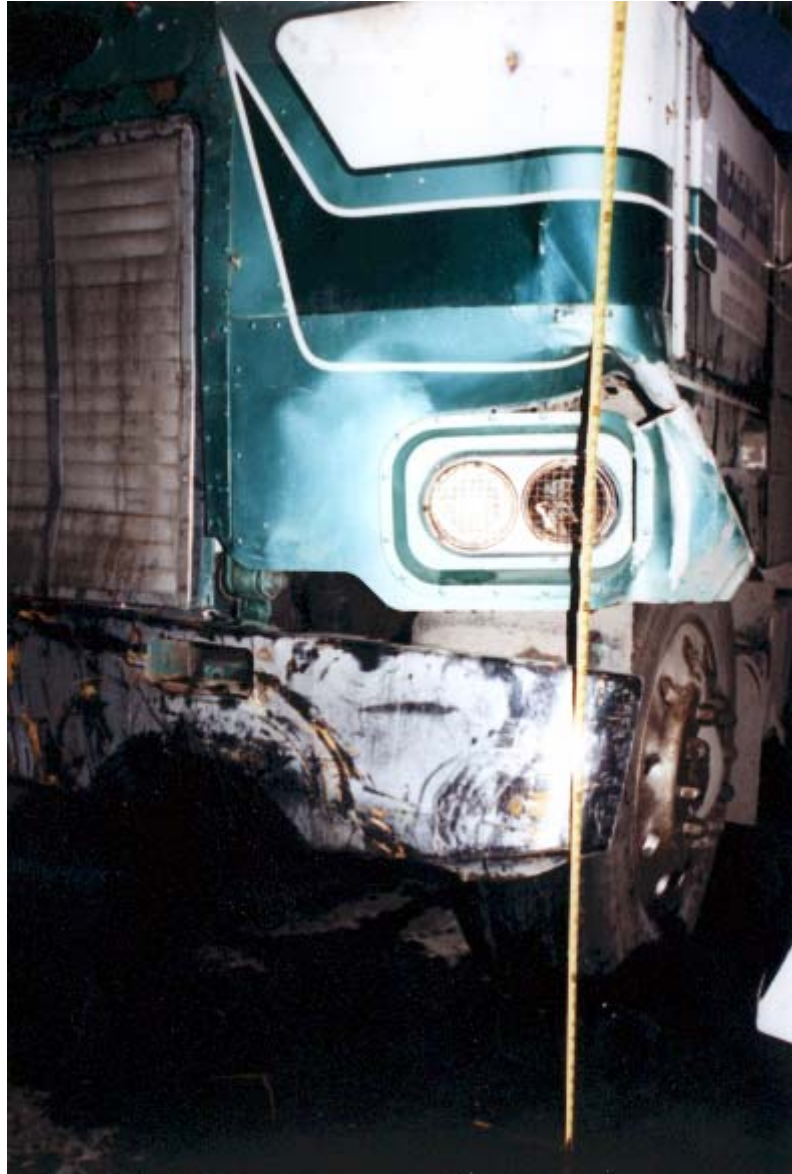
Inspection of the Peterbilt revealed it had sustained minor frontal impact damage. A clear tiremark was visible on the left end of the bumper, consistent with impacting the Volkswagen's left front tire (see Figure 5).

Figure 5 - Left frontal view of Peterbilt tractor shows damage to bumper and left front corner.

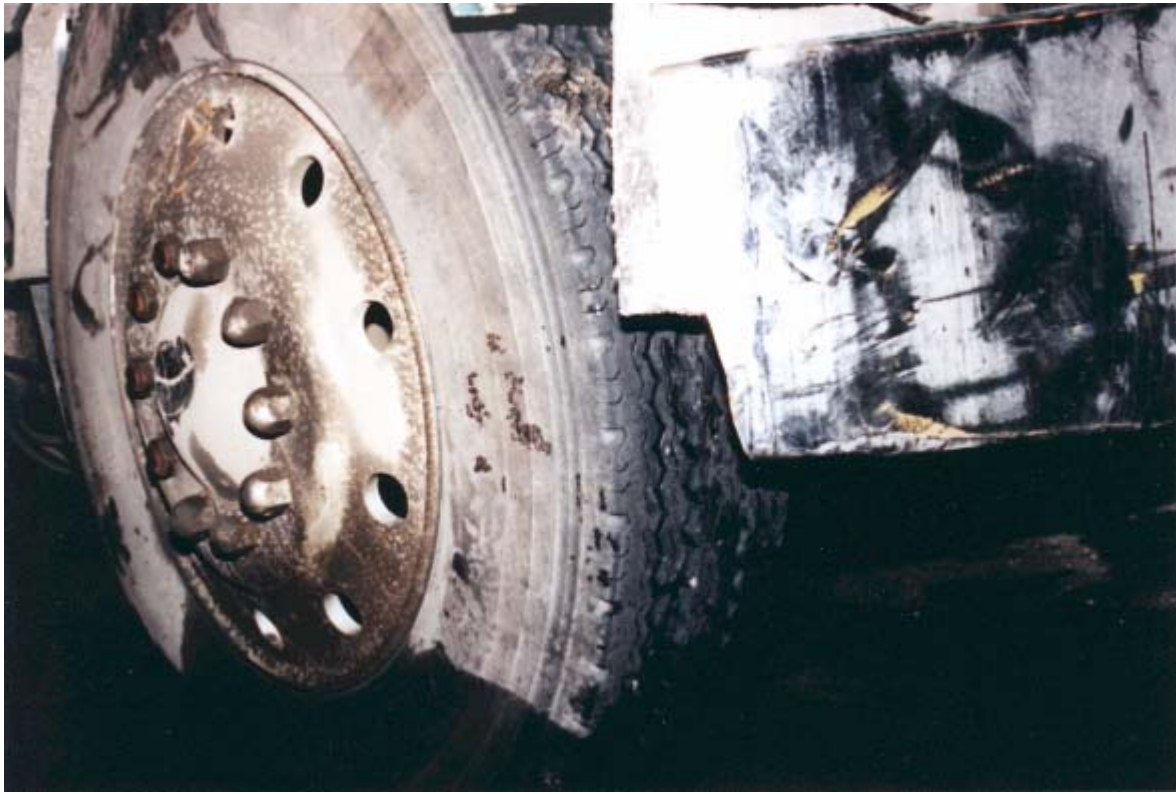
Figure 6 - Close-up view of right end of the Peterbilt bumper showing paint transfers from the Volkswagen Vanagon. The condition of the left front tire is also visible; the condition of this tire was typical of other tires on the vehicle.

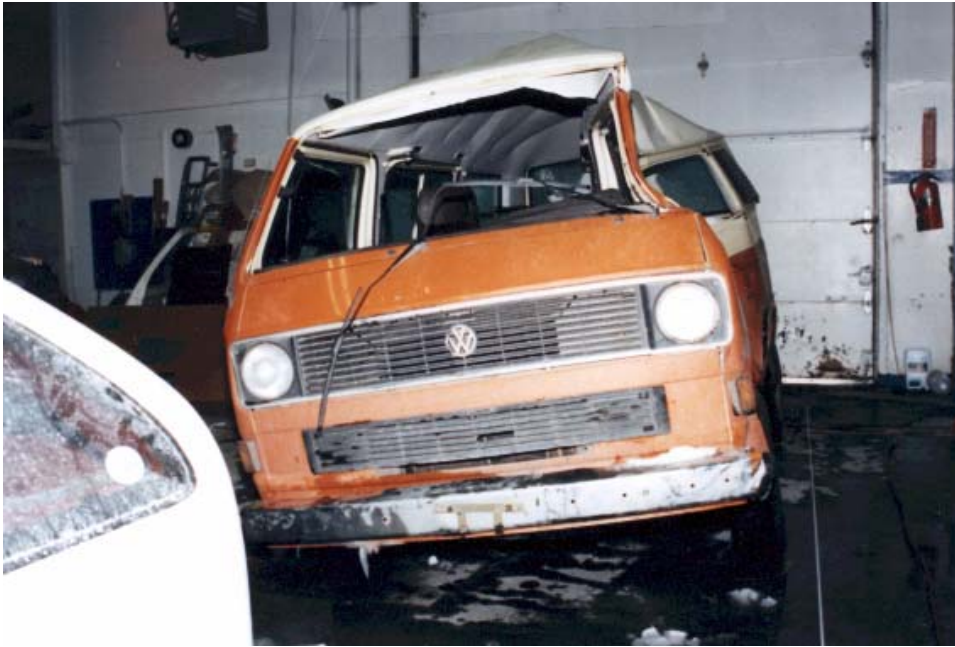
Figure 7 - Frontal view of 1982 Volkswagen Vanagon as inspected on January 5, 1992. Note severe impact damage on the left side.

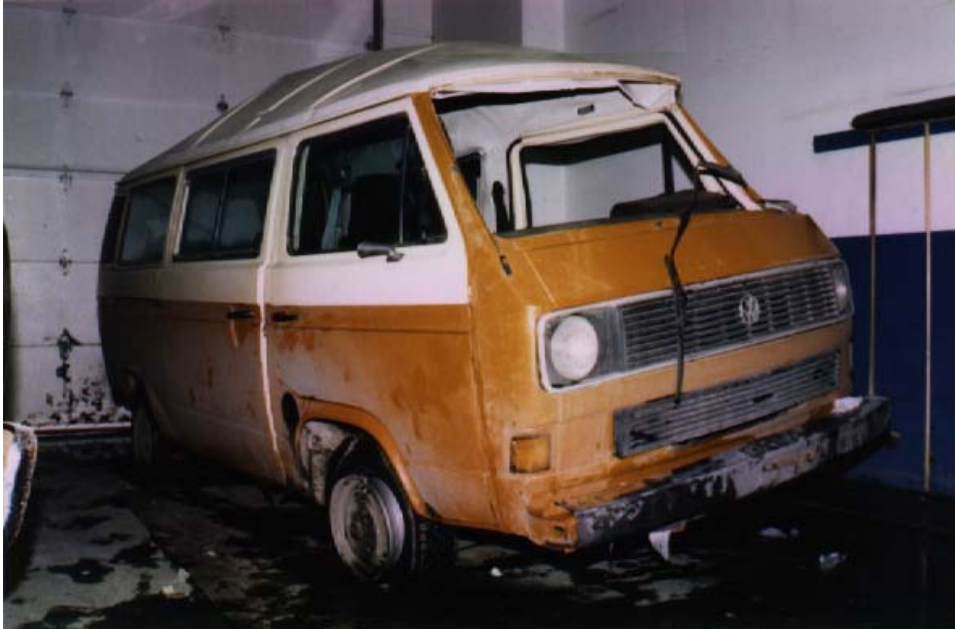
Inspection of the tires revealed all four were Dunlop Max Trak-Grip tires. The tires were of the M+S (Mud and Snow) tread designation and the treads were studded. The front tires had an average tread depth of 13/32 inches; the tread depth of the rear tires was between 5/32 and 8/32 inches. The inflation pressures for the left front and left rear tires were 27 and 22 psi, respectively. Both right-side tires were deboned and uninflated.

Figure 8 - Oblique view of 1982 Volkswagen Vanagon. Note that both right-side tires are debeaded and not inflated. The right front wheel rim shows evidence of lateral skidding that led to the debeading.

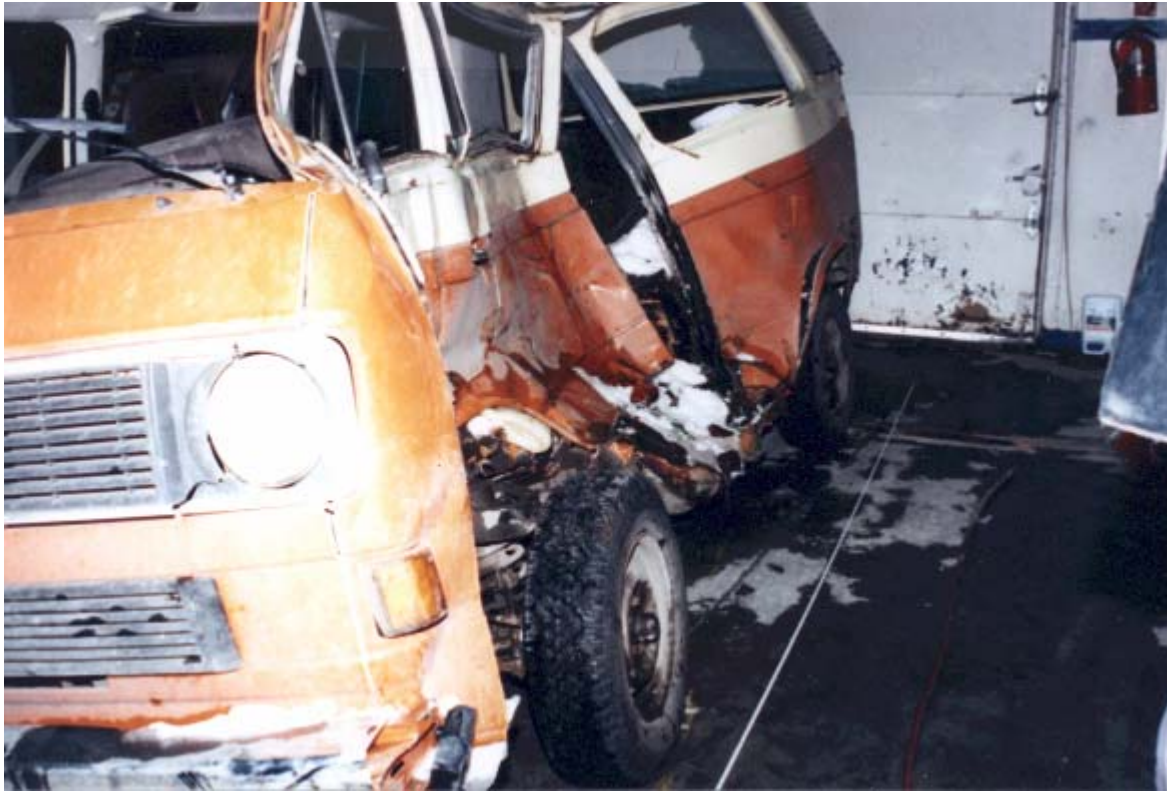
The vehicle had sustained major collision damage on the left (driver's) side. Damage profile measurements revealed the penetration was 20+ inches deep. The characteristic of bumper over-ride was observed in the damage profile, consistent with the height of the Peterbilt's bumper. The driver's seat had become dislodged from its tracks due to collision-related damage.

Figure 9 - View of severe impact damage on the left side of the Vanagon. Tape measure and damage outline drawn on the concrete floor are also visible.

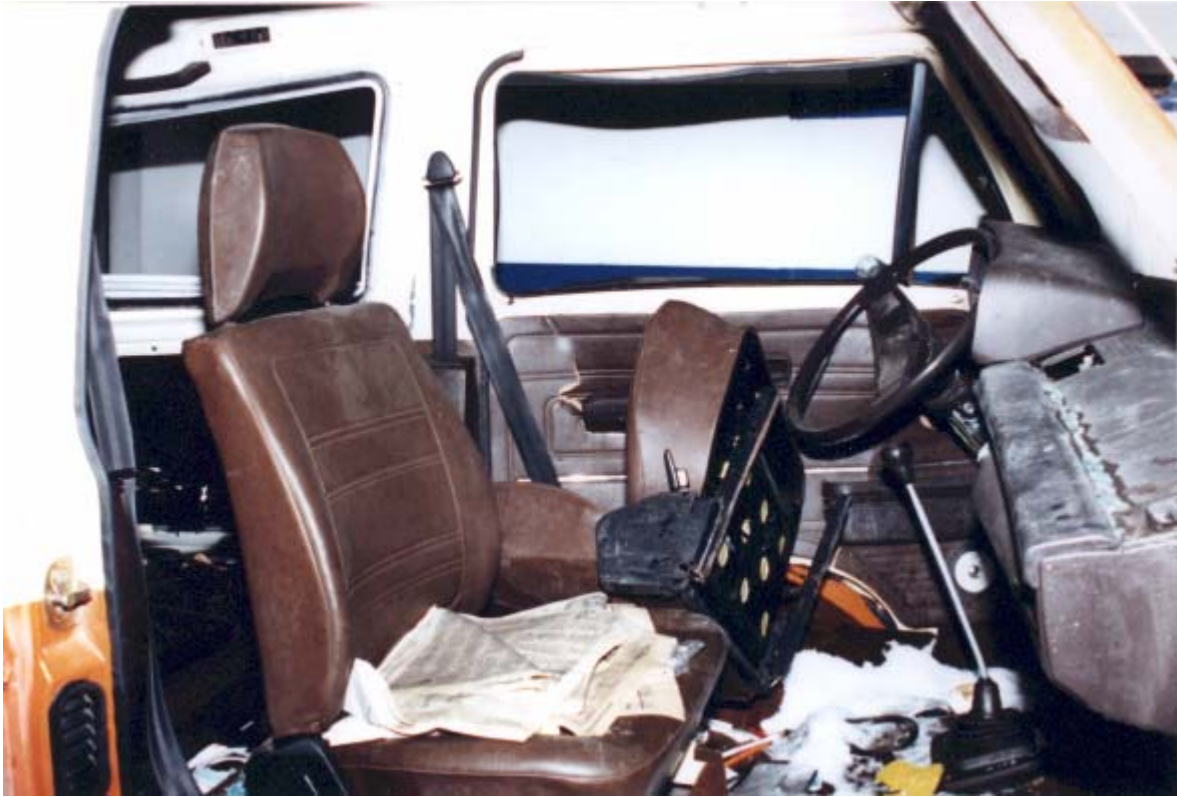
Figure 10 - View of Vanagon interior showing the driver's seat dislodged from its tracks.

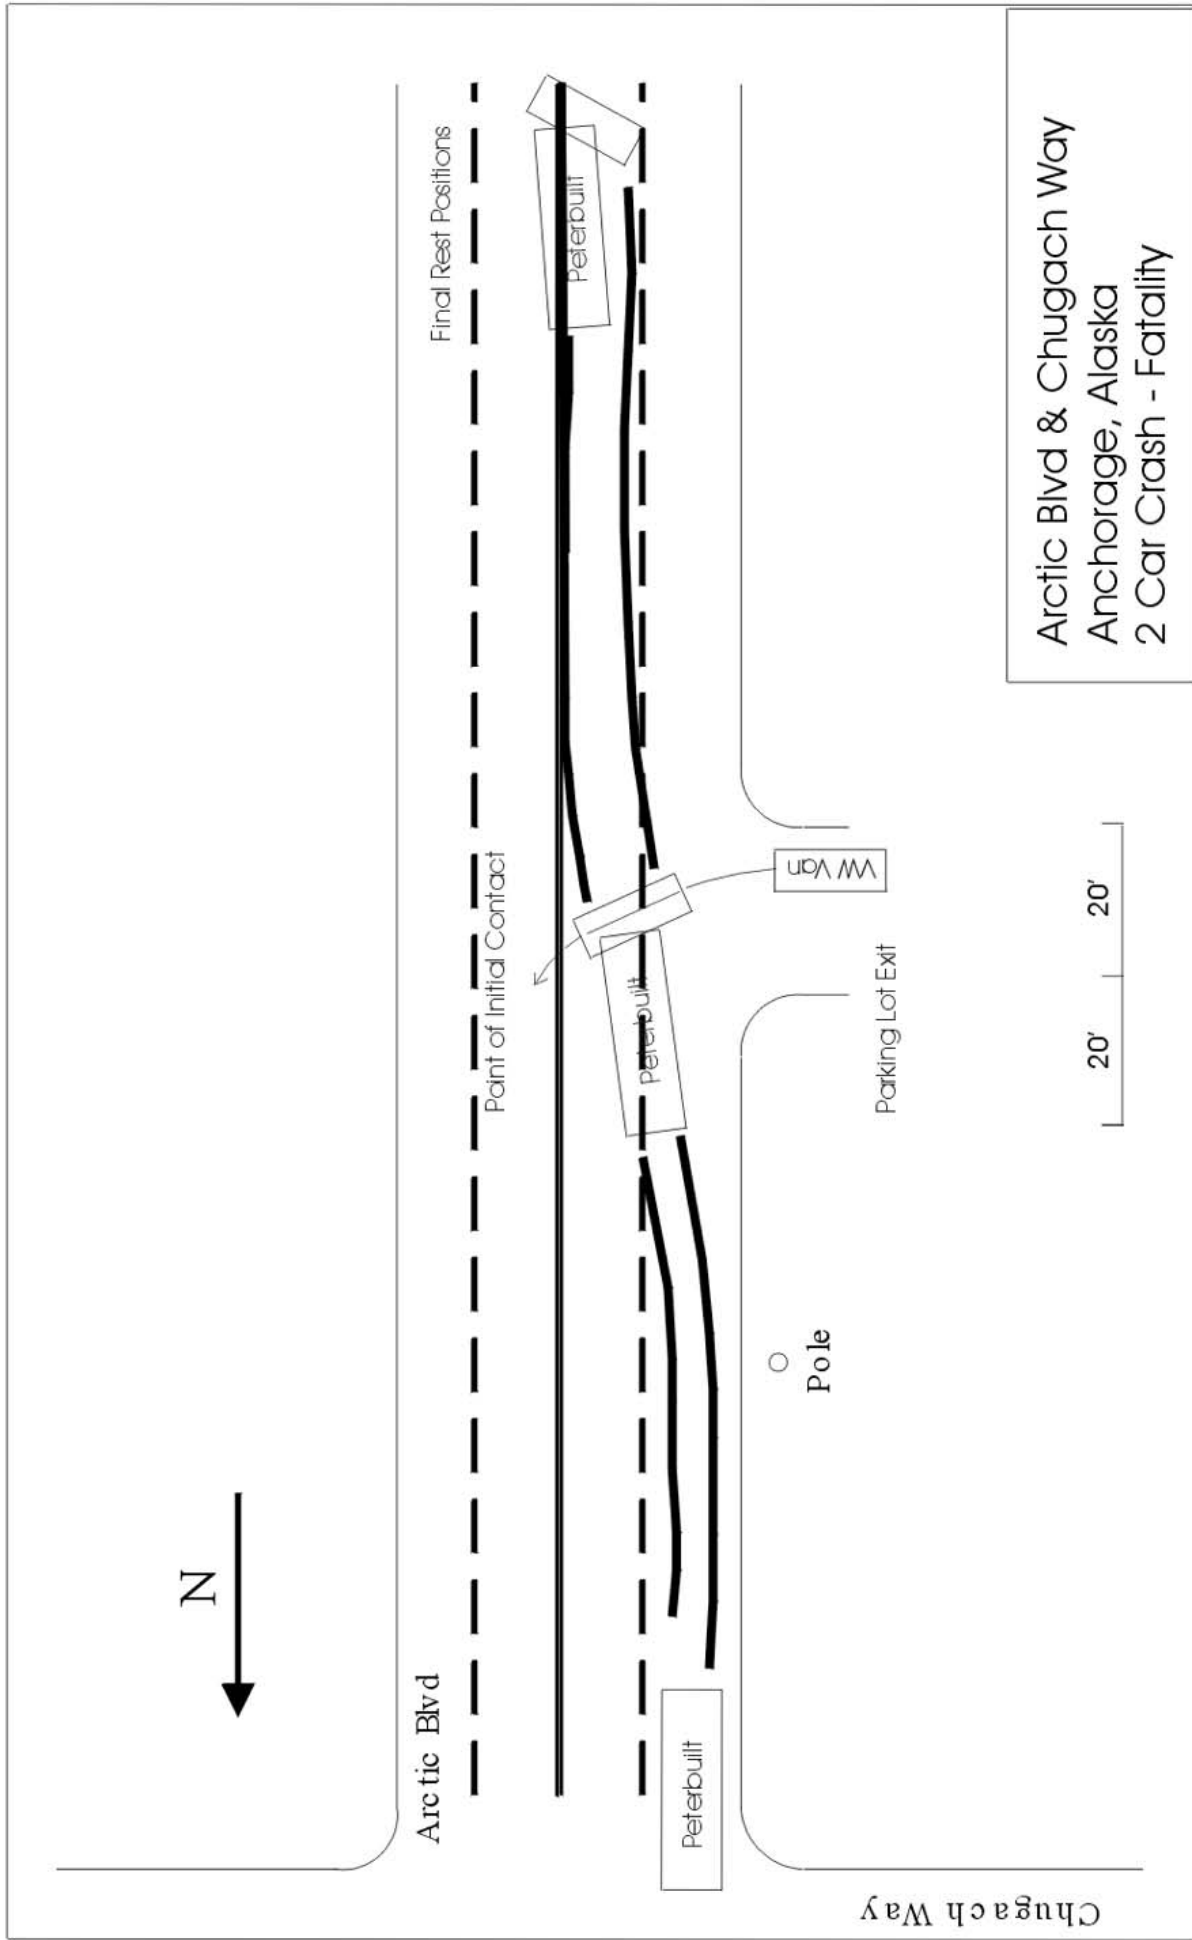
Arctic Blvd & Chugach Way
 Anchorage, Alaska
 2 Car Crash - Fatality

3. The State of Alaska Uniform Police report, Police Case No. 91-162042, prepared by Trooper Tamonian, revealed the Peterbilt vehicle caused 80 feet of pre-impact skidmarks and 84 feet of post-impact skidmarks en route to its rest position. Their location was documented relative to a reference point at the northeast corner of the intersection at Arctic Boulevard and Chugach Way. Severe tire scrubbing resulted from the post-impact sliding of the Vanagon en route to its rest position. The vehicles came to rest in the inside southbound lane; the Peterbilt was straddling the centerline. Traffic was moderate at the time of the accident. A drawing of the crash sequence is shown in Figure 11.

Figure 11 - Schematic of crash sequence showing the Truck southbound on Arctic Blvd as the Van pulled out of the parking lot. The vehicles collided and skidded southerly to their rest positions.

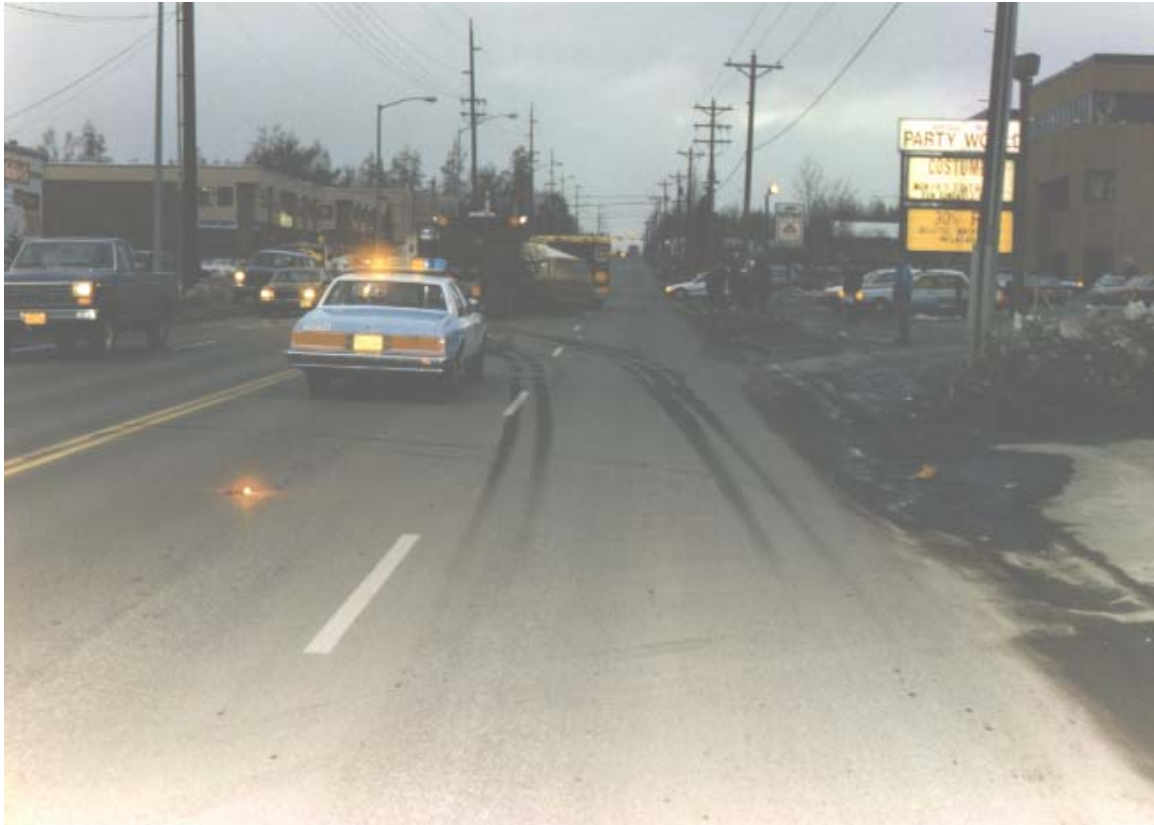
Figure 12 - Crash site photograph of the southbound lanes of Arctic Boulevard. The view is looking south. Note the skidmarks and the vehicles, still in their rest positions. Note also the sign for the Party World convenience store on the west side of the road. Note the north driveway exit from Party World used by the Vanagon as its driver attempted to cross the southbound lanes of Arctic and proceed northbound.

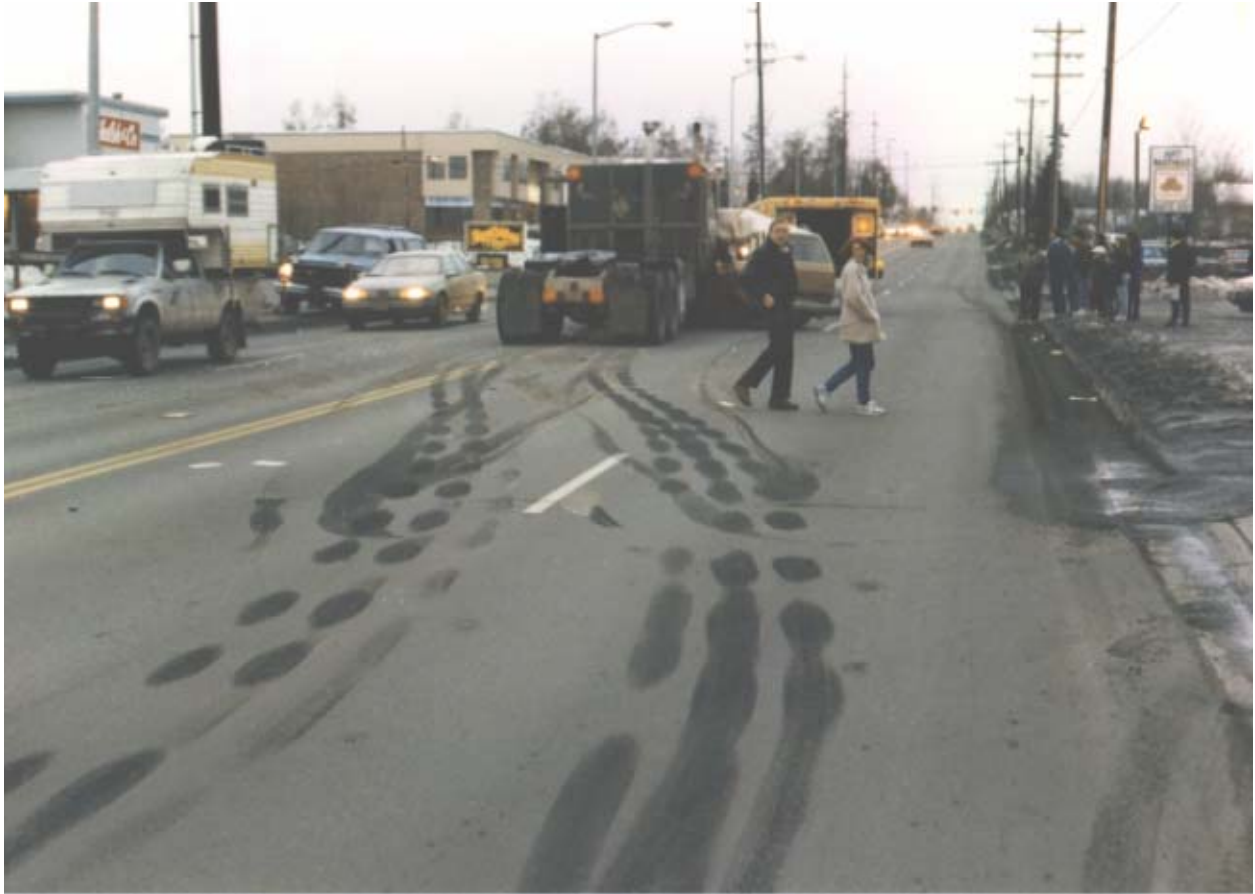
Figure 13 - Closer view of vehicle at the crash site. Note the character of the tire marks. The heavily striated marks were caused by the Vanagon's tires as it was pushed laterally. These marks identify the location of the Vanagon at impact.

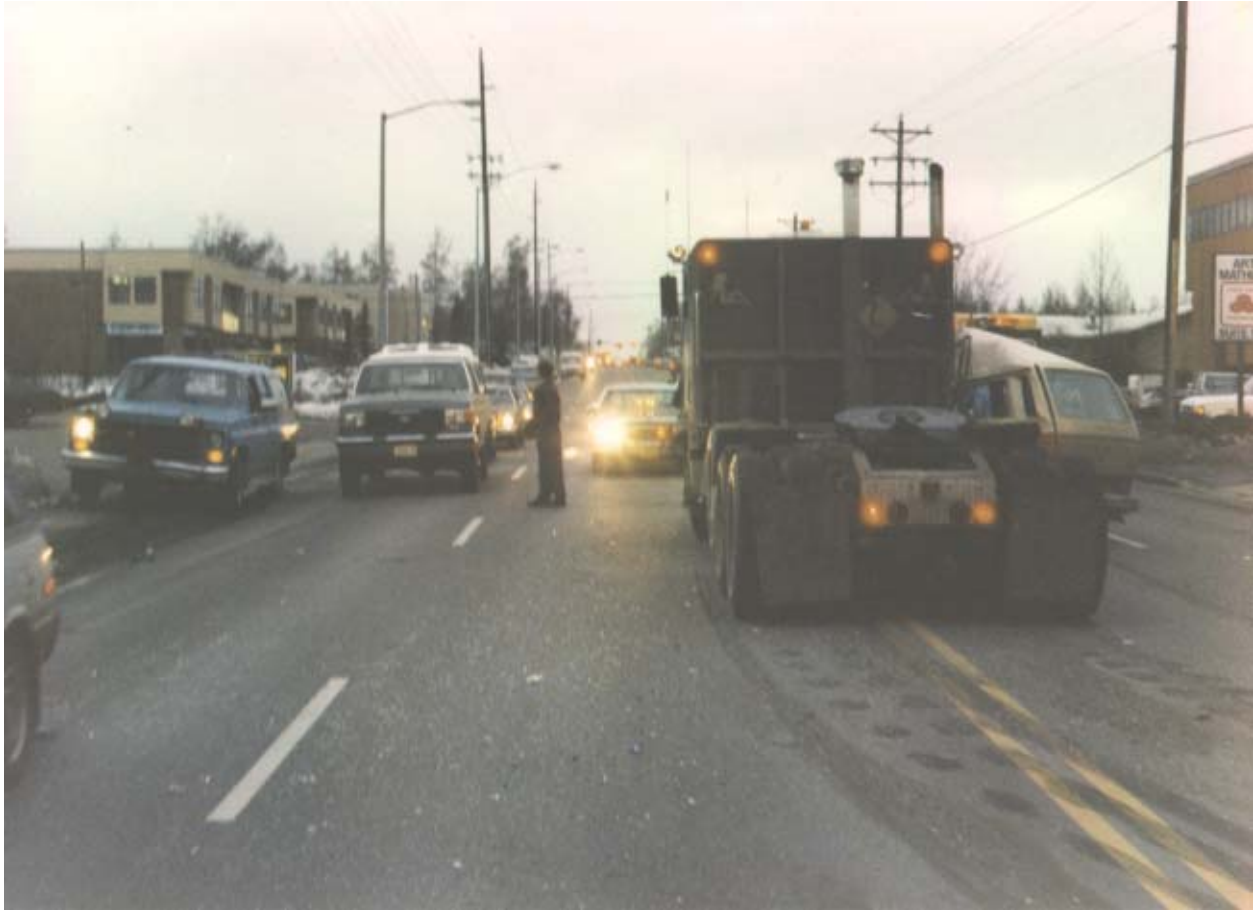
Figure 14 - Close-up view of the Peterbilt at rest. The left front tire is steered to the right, and caused a sweeping scuffmark visible in the photo. This information indicates the driver was attempting to steer back into the southbound lanes after impact.

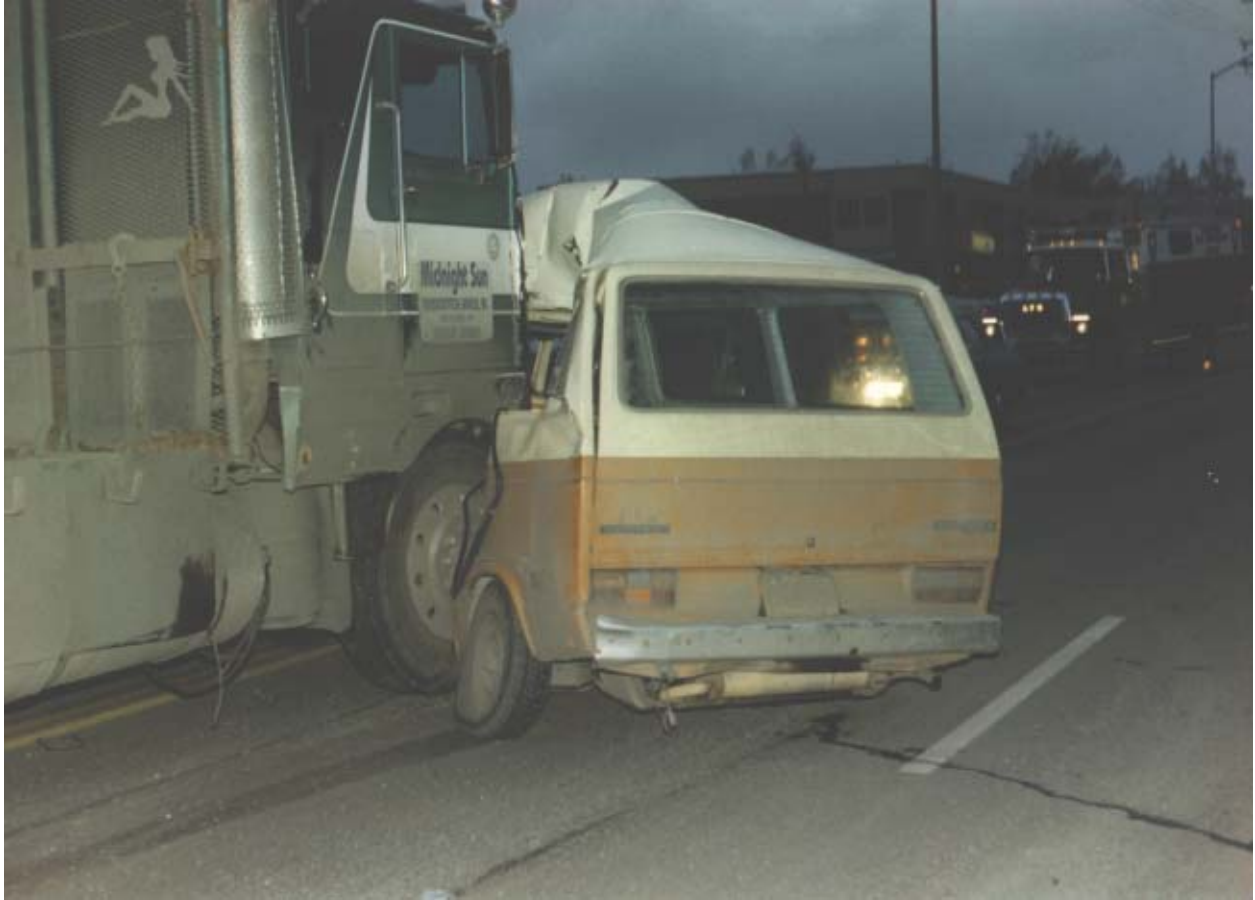
Photographs of the Volkswagen Vanagon revealed severe collision damage on the left side (see Figure 15). Damage to the Peterbilt was minor.

Figure 15 - Close-up of the vehicles at rest showing the severe penetration of the front of the Peterbilt tractor into the left side of the Vanagon. Note also the striated tire mark leading to the left rear tire of the Vanagon, and the thin tire mark leading to the debaded right front tire of the Vanagon.

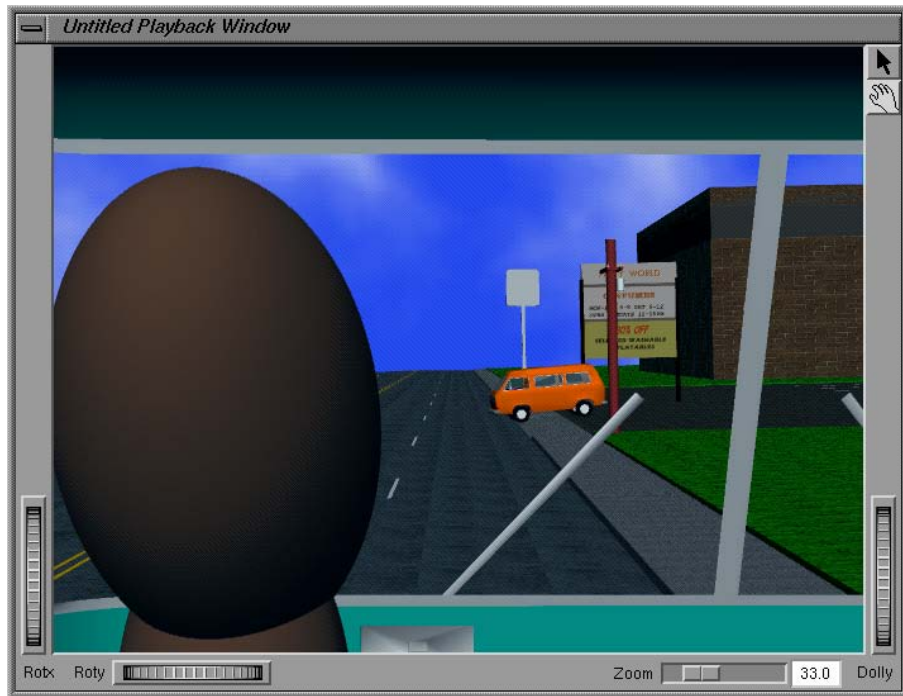
6. After setting up and executing the above simulations, a virtual camera was positioned near the driver's head within each vehicle and the simulations were replayed in real time. The resulting visualizations were videotaped (see videotaped runs 3 and 4). These simulations revealed how the other vehicle appeared as viewed from each driver's position before and during the crash sequence. See Figures 17 and 18.

Figure 17 – Simulated view from driver’s position of Peterbilt truck prior to crash.

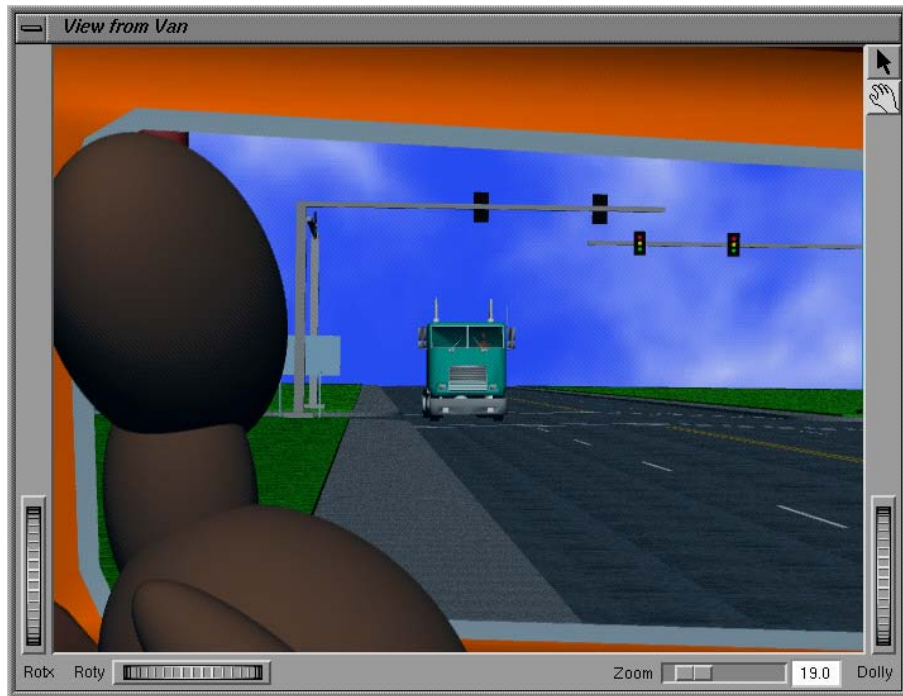
1. Based on the distance available between the oncoming Peterbilt and the Vanagon, the primary cause of the crash was Ms. Walker's driver error. Regardless of the chosen scenario, the Peterbilt was too close when Ms. Walker entered Arctic Boulevard. This conclusion was substantiated by the real-time visualizations of the oncoming Peterbilt as viewed from Ms. Walker's driver-side window.

Figure 18 – Simulated view from driver’s position of VW Vanagon prior to crash.
