**HVE-WP-2017-2**

## **Simulation of a Four-Car Collision Using SIMON/DyMESH**

**James R. Loumiet**

Reprinted From: 2017 HVE Forum White Paper Session

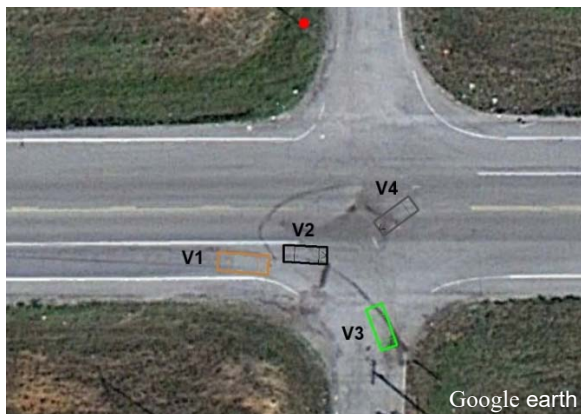
**Figure 1-Vehicle FR Positions & Tire marks**

Site data was collected from post-accident photographs, laser scans of the site, and from *Google Earth Pro* images. One of the *Google Earth Pro* images of the site was taken about 20 days after the accident so that tire marks from the accident were visible in the image. Vehicle final rest positions were determined from both post-accident measurements made by investigating police officers, and from the post-accident photographs using photogrammetry (see Figure 1).

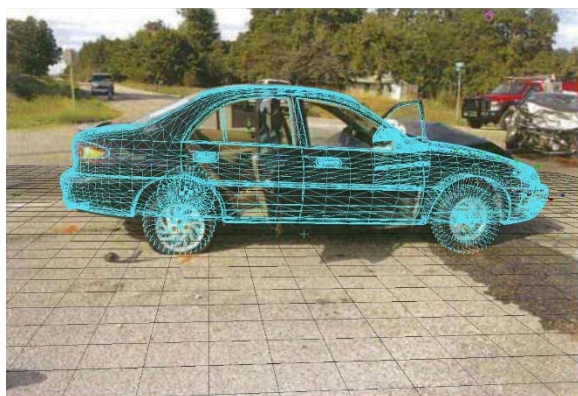
**Figure 2-Ford Escort Photogrammetry**

None of the vehicles were available for inspection for this study. Consequently, all vehicle crush dimensions were determined from post-accident photographs using photogrammetry (see Figures 2, 3, and 4).

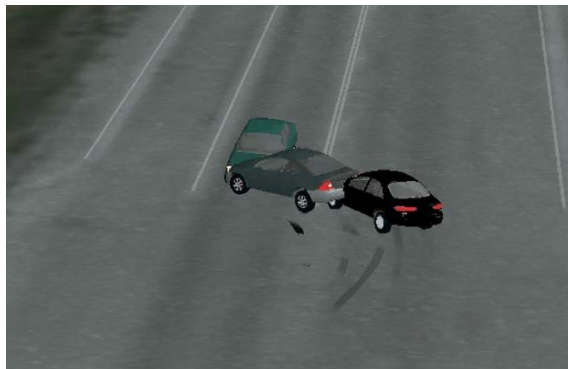
**Figure 5-Overlapping Impacts**

The first and second impacts had to be simulated within the same HVE event because these two impacts initiated only 0.62-second apart with the Escort and Civic still engaged when the second impact between the Civic and the Mazda Protégé occurred (See Figure 5). This point underscores the value of HVE in simulating a collision of this complexity as more traditional reconstruction methods (i.e. “pencil and paper” calculations) would not have been able to reliably handle the overlapping impacts.

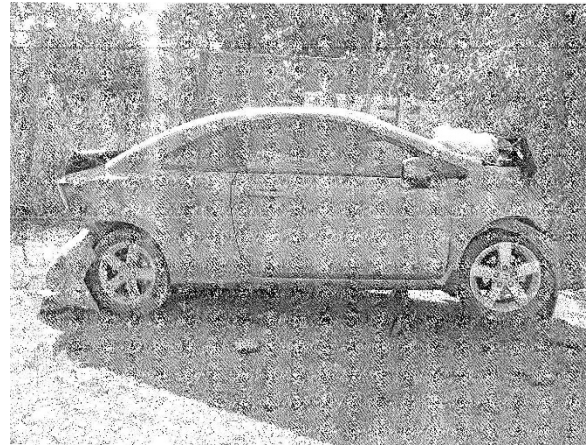
**Figure 6-Honda Civic Crush (Actual)**

A review of the post-accident photographs of the Ford Escort and Honda Civic showed that the front of the Escort underrode the rear end of the Civic during the first impact. Given the 3D nature of this impact and the damage, it was decided to use SIMON/DyMESH to simulate the collision to ensure that all vehicle motion and crush damage were simulated as accurately as possible.

Regarding the analysis of the specific impacts, the first impact involving the Escort and Civic was focused on first. The benefit of using this approach was that the Escort impact speed could be solved independent, for the most part, of the other two impacts. Only a relatively narrow range of Escort impact speeds produced an underride damage pattern consistent with the actual damage to the Escort and Civic (see Figures 6 and 7) and produced the post-impact movements, positions, and tire marks consistent with the site evidence.

An Escort impact speed of 45 mph provided the best fit solution for the first impact. Escort speeds much above 45 mph resulted in a rollover of the Civic, something that did not happen. However, the fact that SIMON/DyMESH can and did predict a

rollover at higher speeds in this case was helpful as it established an upper threshold for the Escort impact speed. Escort speeds much below 45 mph resulted in post-impact damage patterns and motion paths that were not consistent with the evidence.

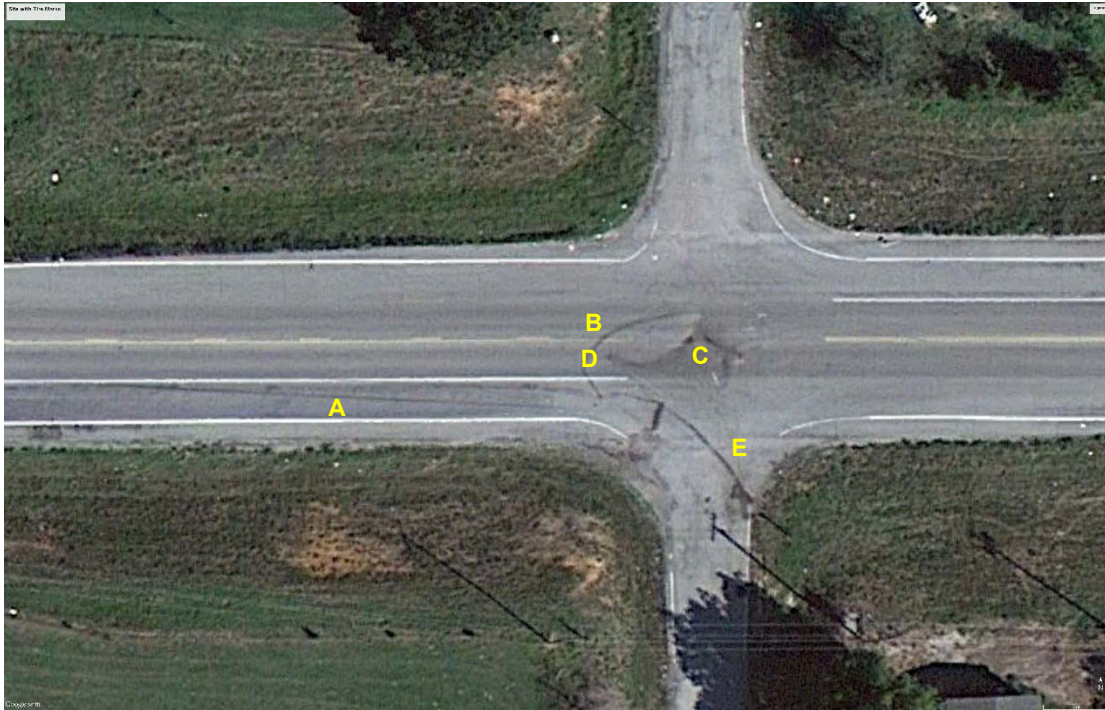
**Figure 9-Actual Tire marks**

As a result of the first two collisions, the Civic yawed about 360 degrees to its final rest position. After the first collision, the Escort continued west and yawed counter-clockwise into the eastbound lanes where it was struck on its front passenger door by the Dodge Intrepid at an impact speed of about 20 mph. Figure 8a-d shows the collision sequence for all three impacts. Figures 9 and 10 show a comparison of the actual tire marks and those generated by HVE.
