Validation of Collision Reconstruction Opinion Utilizing EDSMAC4

Steven Day
California Highway Patrol

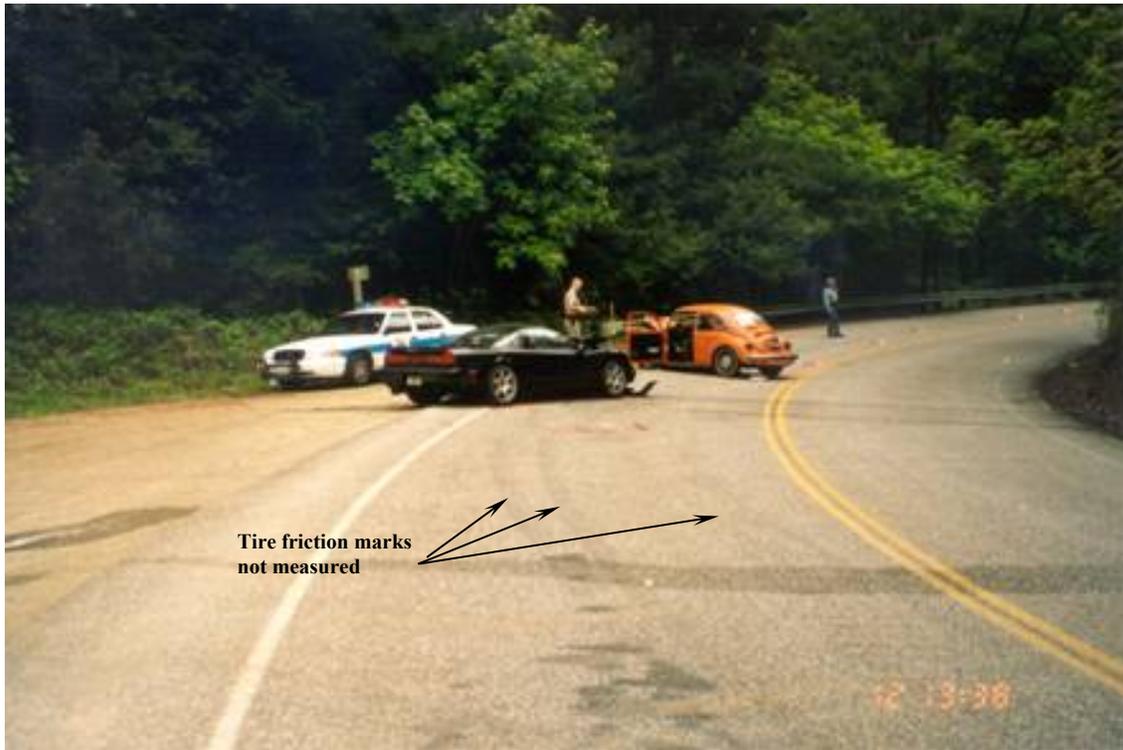
Figure 1: Collision scene looking west

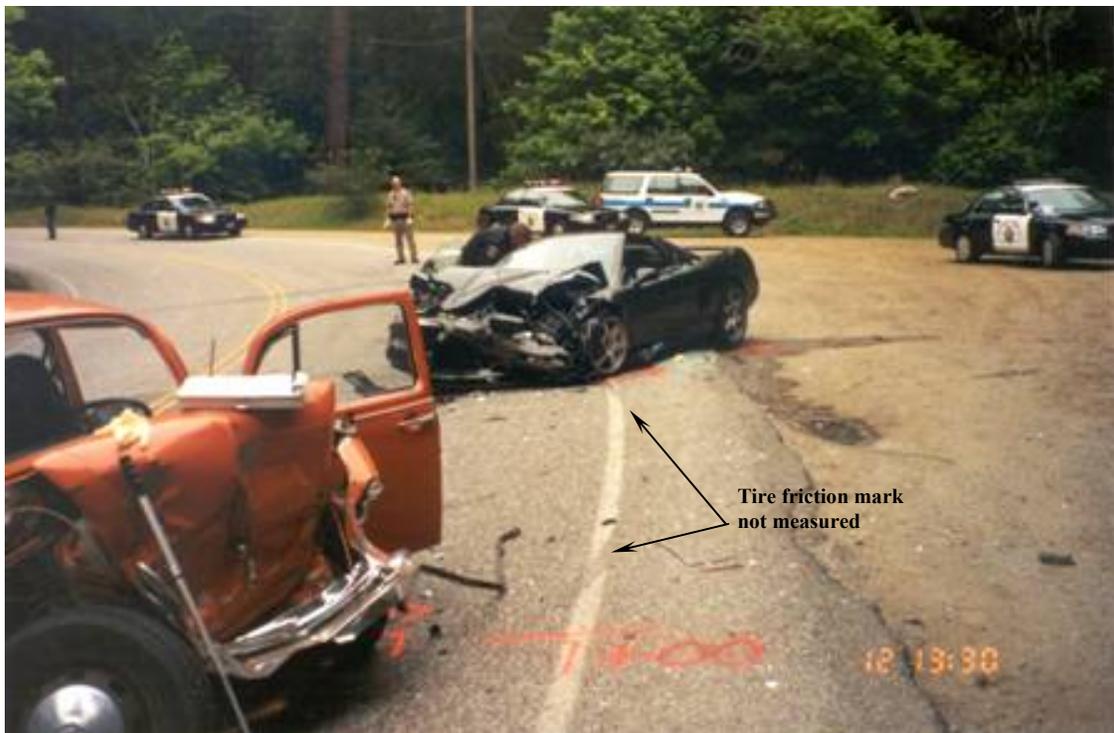
Figure 2: Collision scene looking east

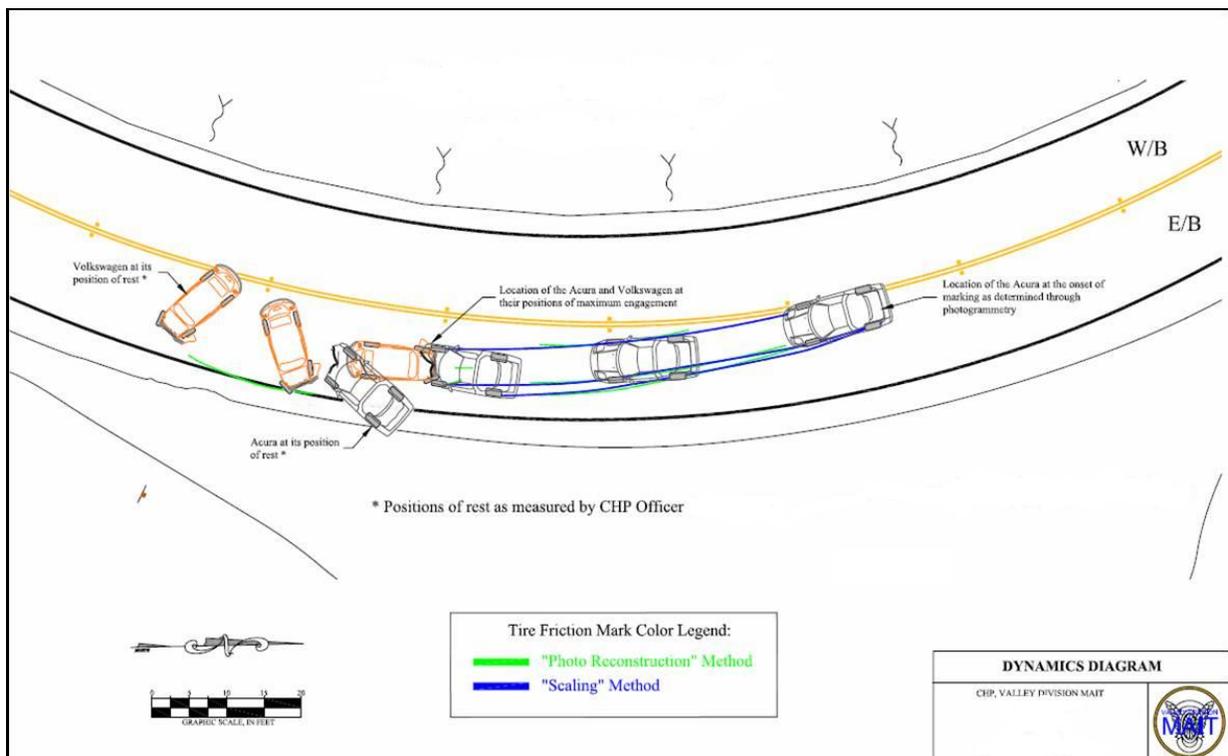
A two-dimensional vehicle dynamics analysis of the collision utilizing the re-established curvilinear tire friction marks was completed (Figure 5). The analysis showed that the three curvilinear tire friction marks, east of the impact location along the Acura's path of travel, led directly to the impact location. In addition, the track width and wheelbase of the Acura matched the re-established tire friction marks. The orientation of the Acura at the impact location, based on the re-established tire friction marks, matched the collision orientation as determined from the damage to the front of the Acura and the Volkswagen.

the survey of the collision site, and the dynamics analysis of the collision provided substantial evidence that the tire friction marks were related to the collision. However, the dynamics analysis showed that the Acura was in an increasing sideslip angle yaw rather than the decreasing sideslip angle yaw as shown by the defense expert. The dynamics analysis indicated that the Acura was in a steering induced yaw, not an emergency brake induced yaw.

Figure 5: 2-D Dynamics Analysis of Collision

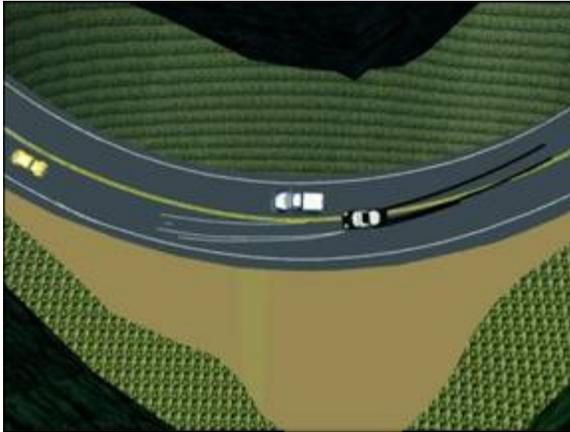
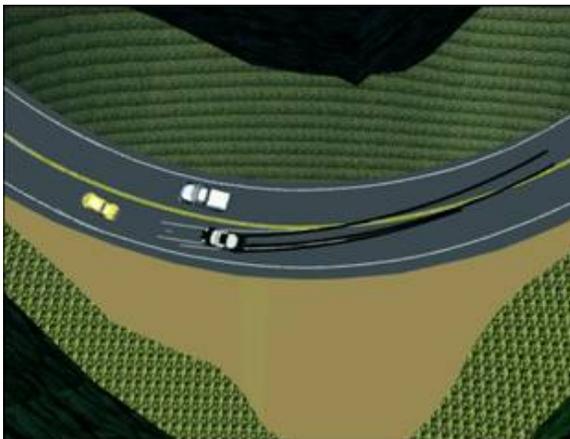
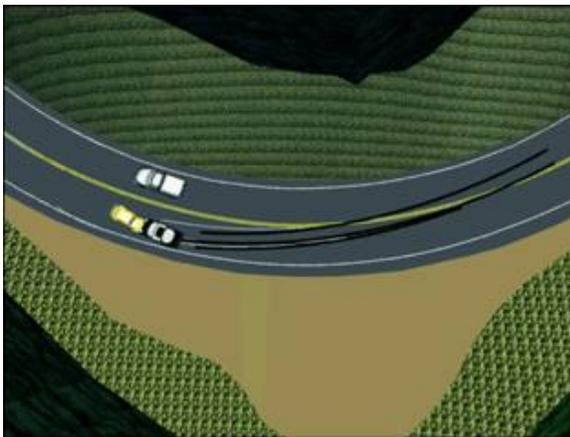
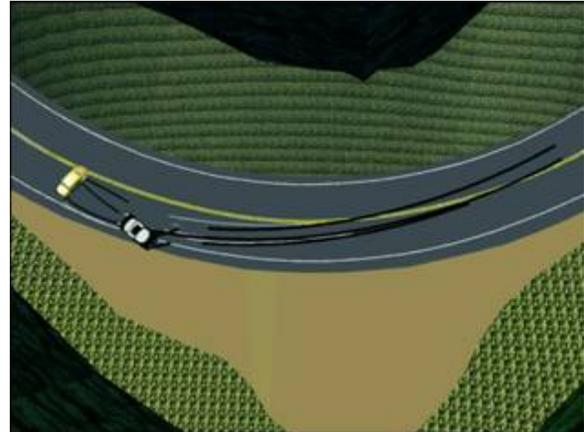
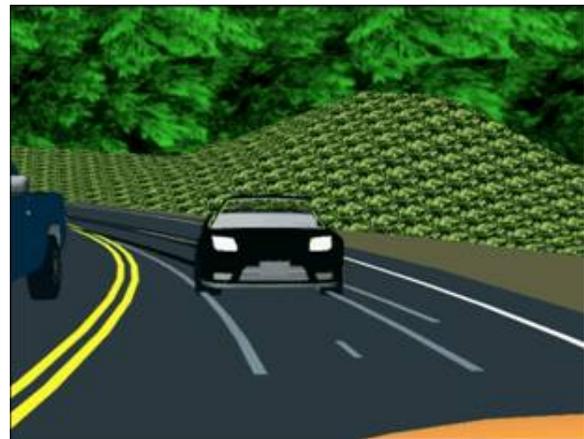
The EDSMAC4 Final Event revealed that the Acura could follow the path dictated by the re-established tire friction marks to the impact location while in a steering only induced yaw and an initial velocity of 55 mph prior to entering the curve (Figures 7a to 7e). As the Acura passed the beginning of the re-established tire friction marks, it was traveling approximately 52 mph. The impact velocity of the Acura was 49 mph and the impact velocity of the Volkswagen was 29.8 mph.

Figure 7a: *Acura entering eastbound lane*

Figure 7d: *Acura and VW at position of rest*

Figure 7b: *Acura within eastbound lane*

Figure 7e: *View from within the VW*

Figure 7c: *Acura and VW at-impact*

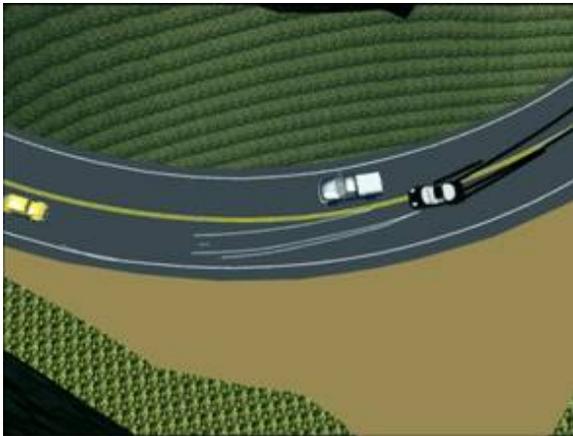
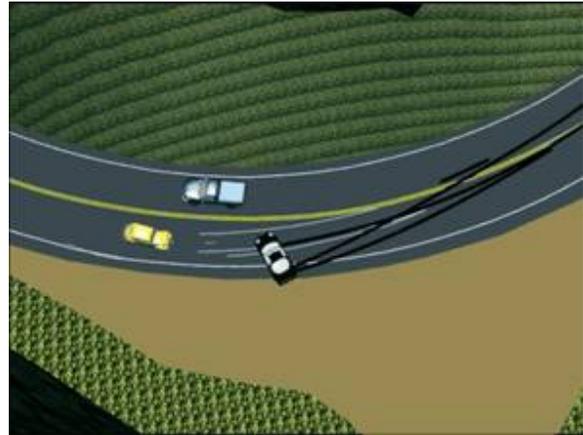
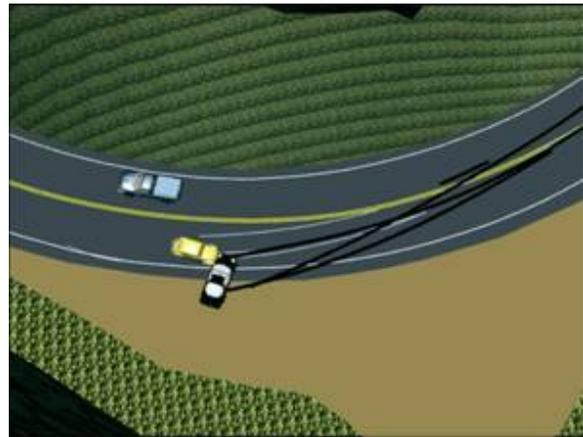
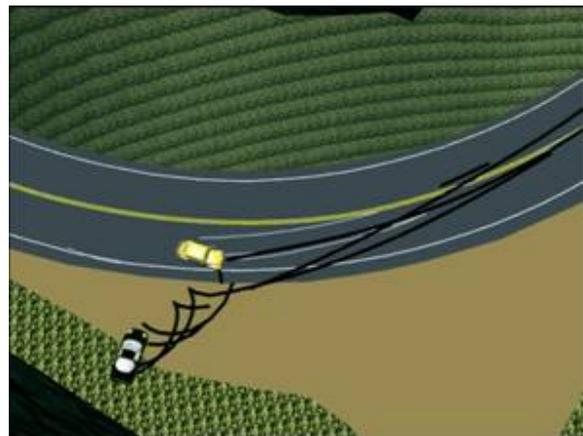
Once the EDSMAC4 Final Event was complete, an additional event was created based on the Acura driver's claim that he utilized the emergency brake of the Acura to put the vehicle into a side skid toward the dirt area, in an attempt to scrub-off speed and stop. The EDSMAC4 Final Event was copied and the driver table for the Acura was changed to apply the emergency brake in the area where the re-established tire friction marks began. As would be expected from a rear brake only application in a curve, the EDSMAC4 E-Brake Final Event (Figures 9a to 9d) caused the rear of the vehicle to wash out to the left creating a greater yaw rate than had been experienced in the steering only EDSMAC4 Final Event. The E-Brake Final Event also demonstrated that a vehicle with an emergency brake application in a curve would have an increasing sideslip angle versus the decreasing sideslip angle as suggested by the defense.

Figure 9a: *Acura beginning emergency brake application*

Figure 9b: *Acura broadside in eastbound lane*

Figure 9c: *Acura at impact with VW*

Figure 9d: *Acura and VW at position of rest*
