## SIMON Simulation of Non-Automotive Vehicle Free Rolling Response

Ciro Ramirez, PhD, PE, CSHO, C. L. Long, Jr., P.E., and R. Joe Thornhill, PhD, PE, CSHO  
Thornhill, Ramirez & Associates, Inc.

### Abstract

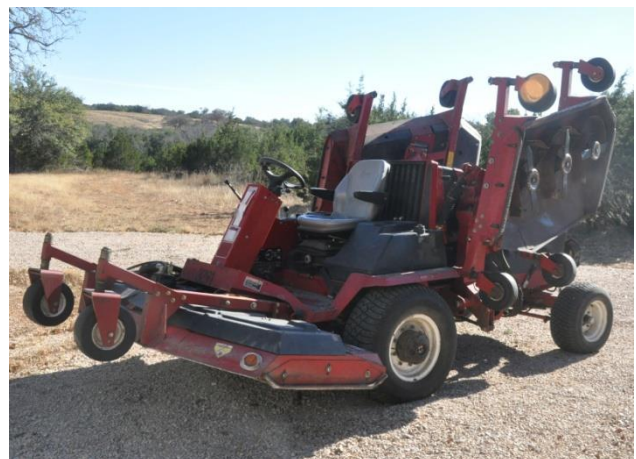
The type of mower involved in this incident was a front drive, rear steer commercial model with three hydraulically actuated bat wing mowing decks, which were raised in the transport configuration (Figure 1). The mower's front wheels are driven by hydraulic motors which would normally be expected to present significant resistance to rolling, but testing of an exemplar mower revealed that the hydraulically selectable two speed front hubs could over-run when the hydraulic system was unpowered, allowing the machine to roll downhill with reduced resistance. The mower is also equipped with hydraulic service brakes, a mechanically actuated parking brake, and split steering brakes, all of which were functional at the time of the incident.

**Figure 1.** Mower decks raised for transport.

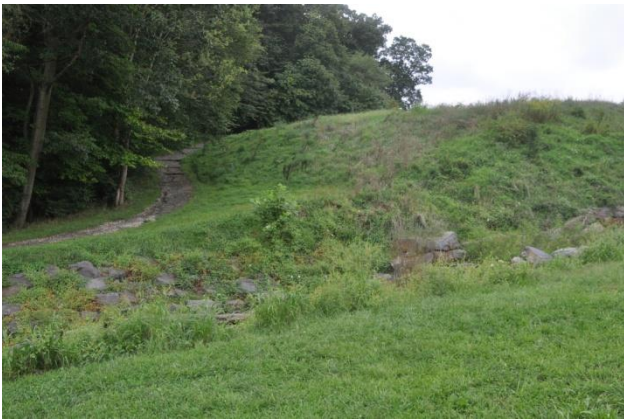
The site of the incident was a slope at a municipal park, shown in Figure 2. Investigating officers found tracks in the unmowed grass, leading from a position just right of the gravel path near the top of the slope to the lip of a ditch, near the center of the photograph. The investigators found no evidence of sliding along these tracks, and concluded that the operator did not attempt to stop the mower with the service brakes. They mapped these tracks, providing a reliable mower path for the simulation. The highest position for the mower was confirmed by witnesses on the far side of the slope, who stated that they saw the mower near the top and heard the engine stop.

**Figure 2.** Slope where incident occurred.

In order to create the terrain for the HVE environment model, the slope was mapped on a fine grid. This grid was then used to create a smooth surface in a 3D CAD system which was imported into HVE. These measurements also revealed that the peak slope along the tracks (approximately 17 degrees) exceeded the mower manufacturer's maximum recommended safe slope angle of 10 degrees. Mower geometry was created using a 3D laser scan of an exemplar mower. The exemplar mower was also used to make static and dynamic measurements needed in creating the HVE simulation.

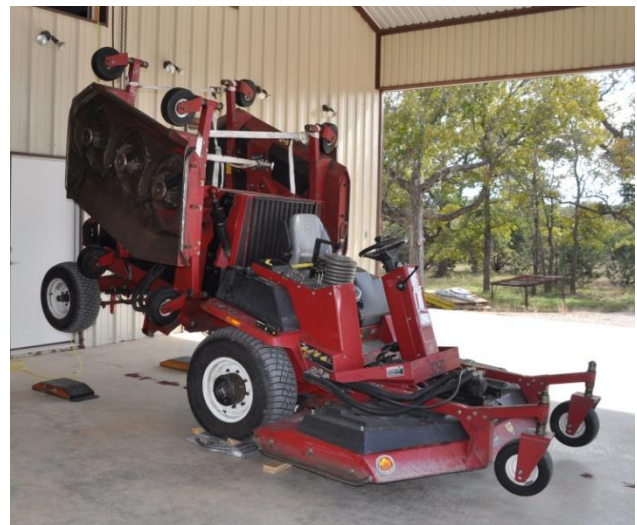
Static measurements of the exemplar mower included mass, center of gravity location, and tire rolling radius. Tire rolling radius was determined by measuring distance traveled on a level concrete surface for several wheel revolutions at each location. Tire pressure for these measurements was set according to the mower manufacturer's specifications. Center of gravity location was determined using scales and lifting one end of the mower with an overhead hoist (Figure 3). Tire compliance was also measured at each location using wheel scales and measured vertical displacement of the steel wheel at several wheel loads. The static stability ratio calculated using these measurements agreed well with tilt table testing of the mower according to the safety standard ANSI/OPEI B71.4-1999 [1].

**Figure 3.** Center of Gravity Measurement.

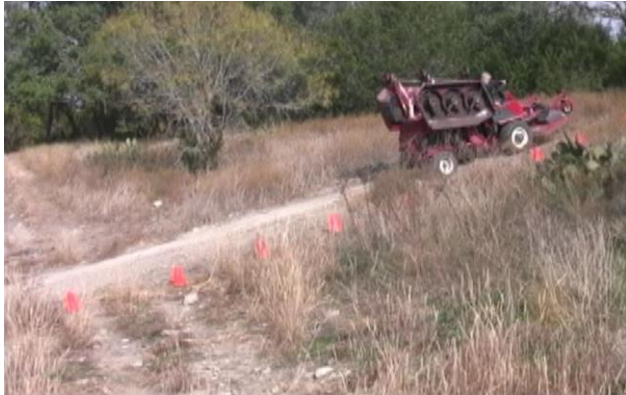
The construction of an HVE simulation which could faithfully mimic the free rolling response of the mower required precise measurement of the effective drag factor created by over-running of the two hydraulic drive motors. Measurements of the braking capacity of the service and steering brakes were also required. In order to make these measurements in a realistic setting, a test slope was used (Figure 4). The test slope was mapped in detail so that the slope angle could be measured and an HVE environment

**Figure 4.** Test slope for determining drag factor.

Test instrumentation consisted of a GPS-based VBOX mini, capable of measuring position, velocity, and acceleration. The test procedure used was to position the mower at the top of the slope, apply the service brakes, and stop the engine. The brakes were released, and the mower was allowed to roll rearward until it transitioned onto the level area. Service brakes were then used to stop the mower as quickly as possible. In most cases, the operator was able to lock the drive wheels with the service brakes. The velocity change over the first 30 feet of roll

was used to calculate an effective drag factor, corrected for slope. Fourteen runs were used to calculate an average drag factor of 0.11 for the over-running condition. The velocity data was also used to calculate an effective braking drag factor as the mower came to a stop, which averaged 0.32 for the service brakes and 0.24 if the auxiliary steering brakes were used instead. Separate braking testing was also done on level concrete, yielding higher braking drag factors, but the lower values from the slope testing were used to obtain conservative estimates from the simulation results.

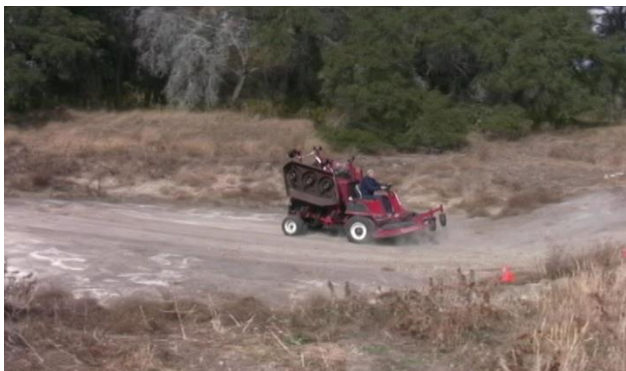
model created to duplicate the test conditions. The sloped section of the test site was approximately 35 feet long, and ended in an approximately level area long enough to safely bring the mower to a stop (Figure 5). The average slope angle for the test site was 13.8 degrees, which was comparable to the average slope angle at the incident site.

**Figure 5.** Level area at bottom of test slope.

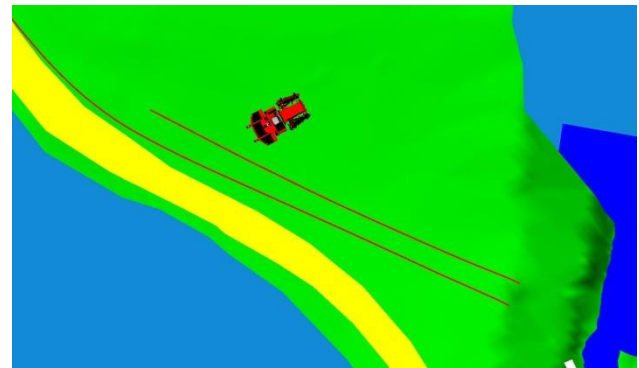
Once the effective drag of the mower drive system had been determined, a simulation of the event could be run. The path of the mower during the incident was marked on the HVE environment, and a series of runs was done to determine any steering required to follow the path. Although the path follower option was tried, manual iteration of the steering history was ultimately used to achieve the best possible match. The approximate path distance from the top of the incident slope to the edge of the ditch was approximately 122 feet. The resulting simulation of the actual event calculated that the mower took approximately 8.6 seconds to reach the edge of the ditch after it started rolling rearward, reaching a top speed of approximately 12 mph. It was also found that, without steering input, the mower tended to move in a "hook" motion due to the side slope, deviating from the actual path observed. If the mower had moved in this fashion, it would likely have come to a stop after turning approximately 180 degrees, and might have headed forward down the slope.

Figure 8. Deviation from path without steering.
