HVE-WP-2018-1

A Person and His Bicycle are Struck by a Pickup Truck, but was He Riding or Walking the Bicycle?

Thomas Jenkyn, PhD PEng
TLS Biomechanics & Engineering
London, ON, CANADA

Reprinted From: 2018 HVE Forum White Paper Session

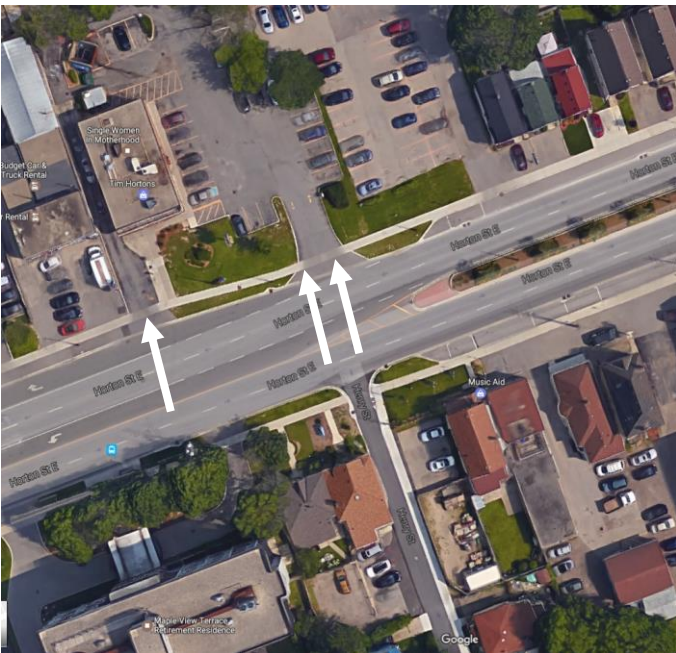
Figure 1: The intersection of Horton Street and Henry Street (Google Earth). North is upward. The exit from the drive-thru (single white arrow) and the exit from the parking lot (pair of white arrows) are shown.

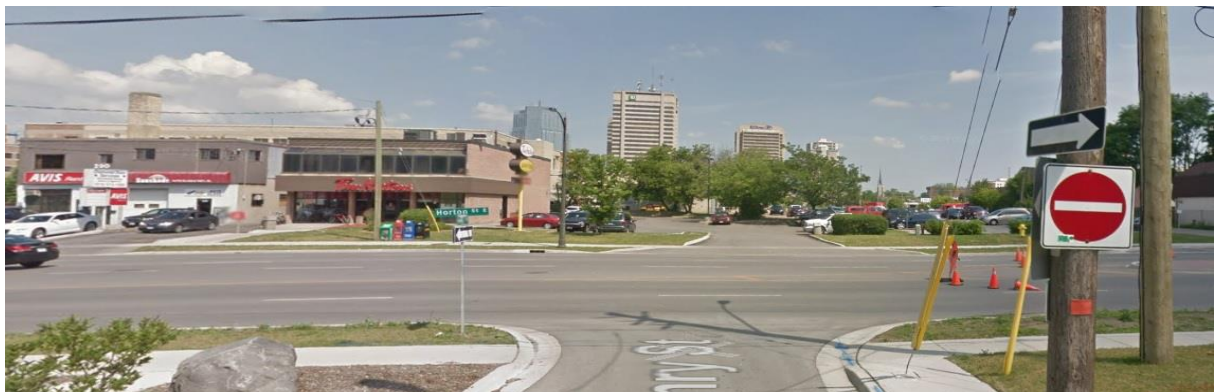
Figure 3 (below): Street view of the intersection of Henry Street and Horton Street facing north along Henry. Note the exit to the main portion of the Tim Horton's parking lot is almost straight ahead. Also note the signage on the east side of Henry Street clearly indicating that this is the wrong way for traffic.
