# Simulating Train Collisions with Highway Vehicles using EDSMAC4 and other programs

National Transportation Safety Board

## WAGONER, OKLAHOMA CRASH

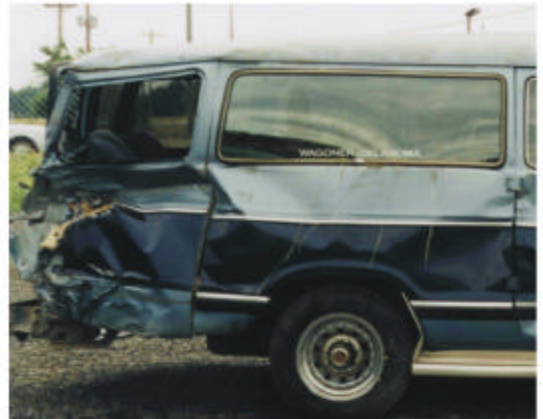
**Right rear side  
of van**

At impact, the pilot plow of the lead locomotive contacted the right rear side of the van with approximately 34 inches of overlap. The Dodge van received extensive damage with inward crush reaching a maximum depth of 22 inches on the right rear corner of the van. From the impact area the van rotated clockwise approximately 340 degrees about its vertical axis, traveled onto the south roadside on the west side of the crossing, and came to

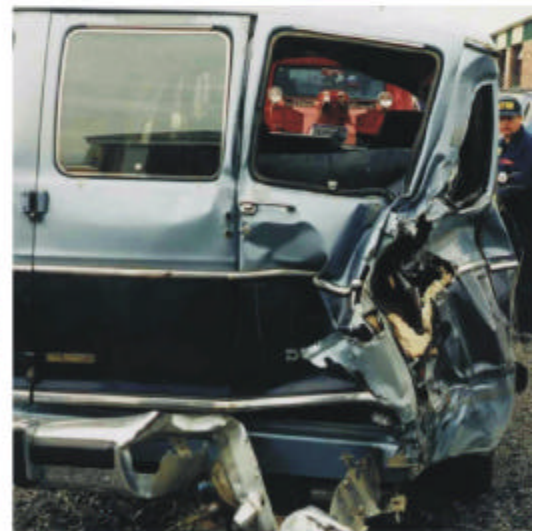
**Rear of  
van**
