## Human Performance - Can Visual Phenomena Be Recreated In HVE?

**Lawrence E. Jackson, P.E., M.S., ACTAR**  
National Transportation Safety Board

### ABSTRACT

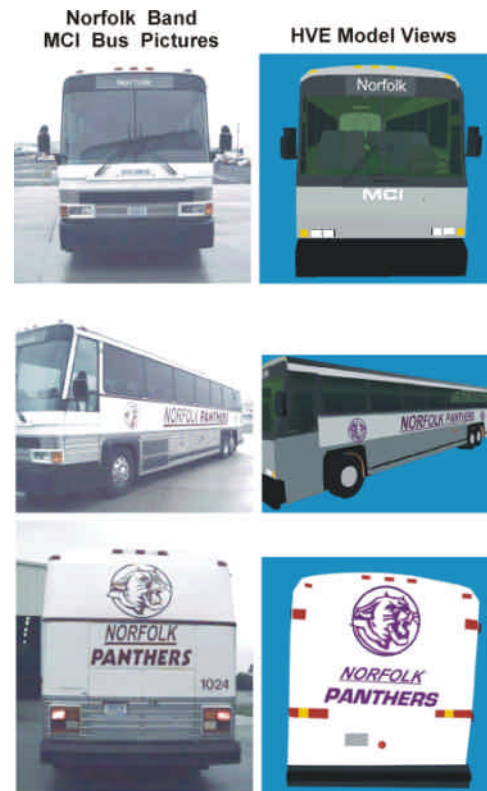
**Figure 2 – Comparison of pictures of the Norfolk motor coach to the HVE model**

To explore potential views of the accident driver, the scene and vehicles needed to closely represent the actual operating environment. This was accomplished through the on-scene mapping of the vehicles and roadway and through the development of a detailed three-dimensional scene in HVE. The vehicle models can be seen in Figures 2 and 3. Detailed information concerning the development of the scene and the vehicle models can be found in the NTSB public docket<sup>3</sup>.

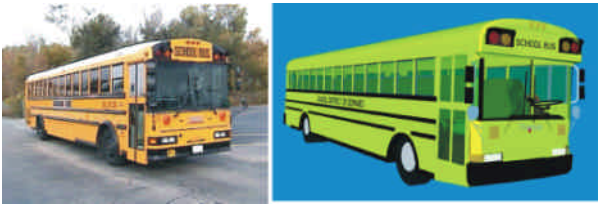
**Figure 3 – Comparison of the sister bus and the HVE model.**
