Simulation of a Side Impact and Vehicle Rollover Using EDVSM and EDSMAC4 within HVE

James E. Flynn, Stephen Harper, Howard Underwood,
Robert Buckert and Phillip Parks
J2 Engineering, Inc.

ABSTRACT:

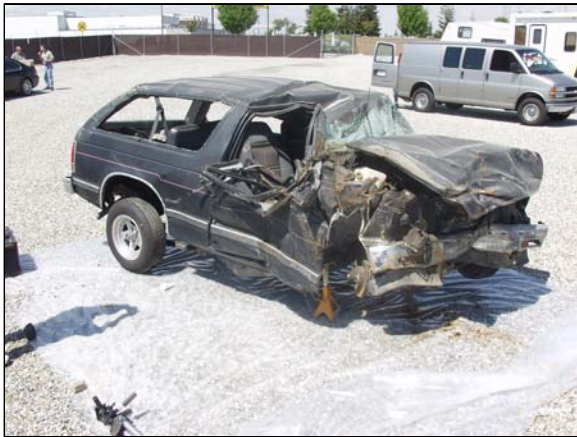
Both the Blazer and the Crown Victoria were available for inspection. The Blazer was found to have sustained an impact to the front end, the direction of which primarily was from front to rear. The PDOF was approximately 20 degrees. Maximum engagement and maximum residual crush of approximately 31 inches was located at the right front corner of the vehicle.

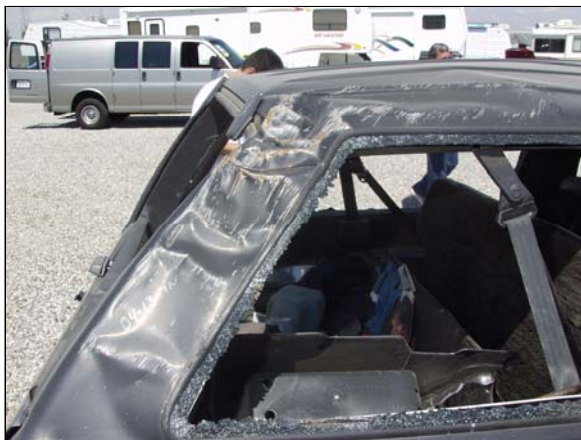
Evidence of rollover was also apparent, with damages located on the roof panel, the right 'A' pillar and the right 'C' pillar.

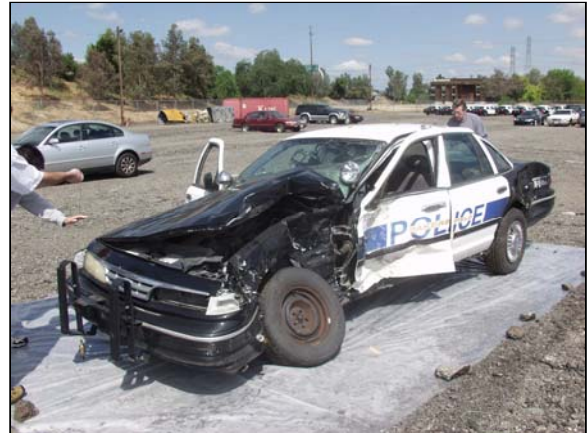
The inspection of the Crown Victoria revealed that it had sustained an impact to the left side, the direction of which primarily

was from left to right. The PDOF was -70 degrees. Maximum engagement and maximum residual crush of approximately 18 inches were located at the left front wheel.

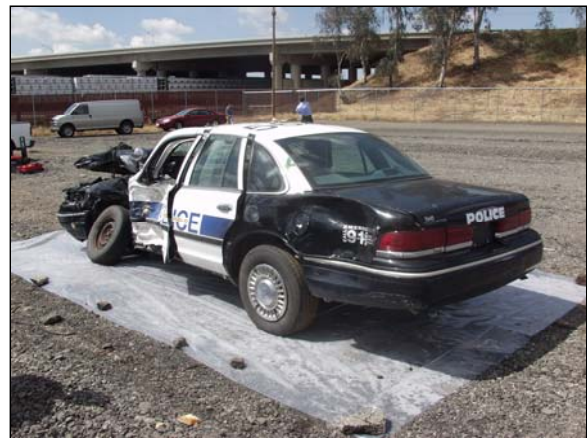
Evidence of secondary contact was apparent at the left rear quarter panel of the Crown Victoria. The location of the damage indicated that, as the rear quarter panels of the vehicles came together, the right rear tire of the Blazer was not in contact with the roadway surface.

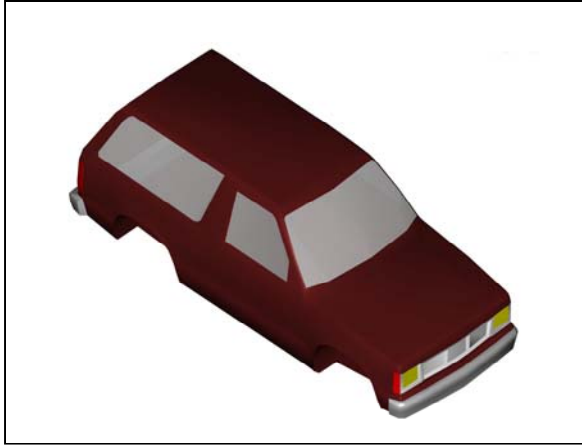
A three dimensional model of the Blazer was purchased from 3D Cad Browser. A 3D model of the Crown Victoria was

modified from the EDVDB geometry File. Cinema 4D was used to create the police vehicle markings.
