**STAGED COLLISION AND DAMAGE DATA REPORT  
FOR ACCIDENT RECONSTRUCTION  
OF THIRTY (30) TEST VEHICLES  
VOL. II**

| 4. Title and Subtitle<br>Volume Three (3) - Staged Collision and Damage Data<br>Report for Accident Reconstruction of Thirty (30)<br>Test Vehicles | | | | 5. Report Date<br>January 1981 | |
| 16. Abstract<br>The thirty (30) test vehicles were impacted tested for compliance with FMVSS 212/219/301-75 and documented in previous submitted reports.<br><br>As a parallel non-conflicting effort, the test vehicles were instrumented with accelerometers to measure vehicle acceleration resultants. The vehicles were also identified for residual crush and collision deformation classification (CDC) measurements. The results of this effort are documented herein and presented in three (3) volumes. | | | | | |

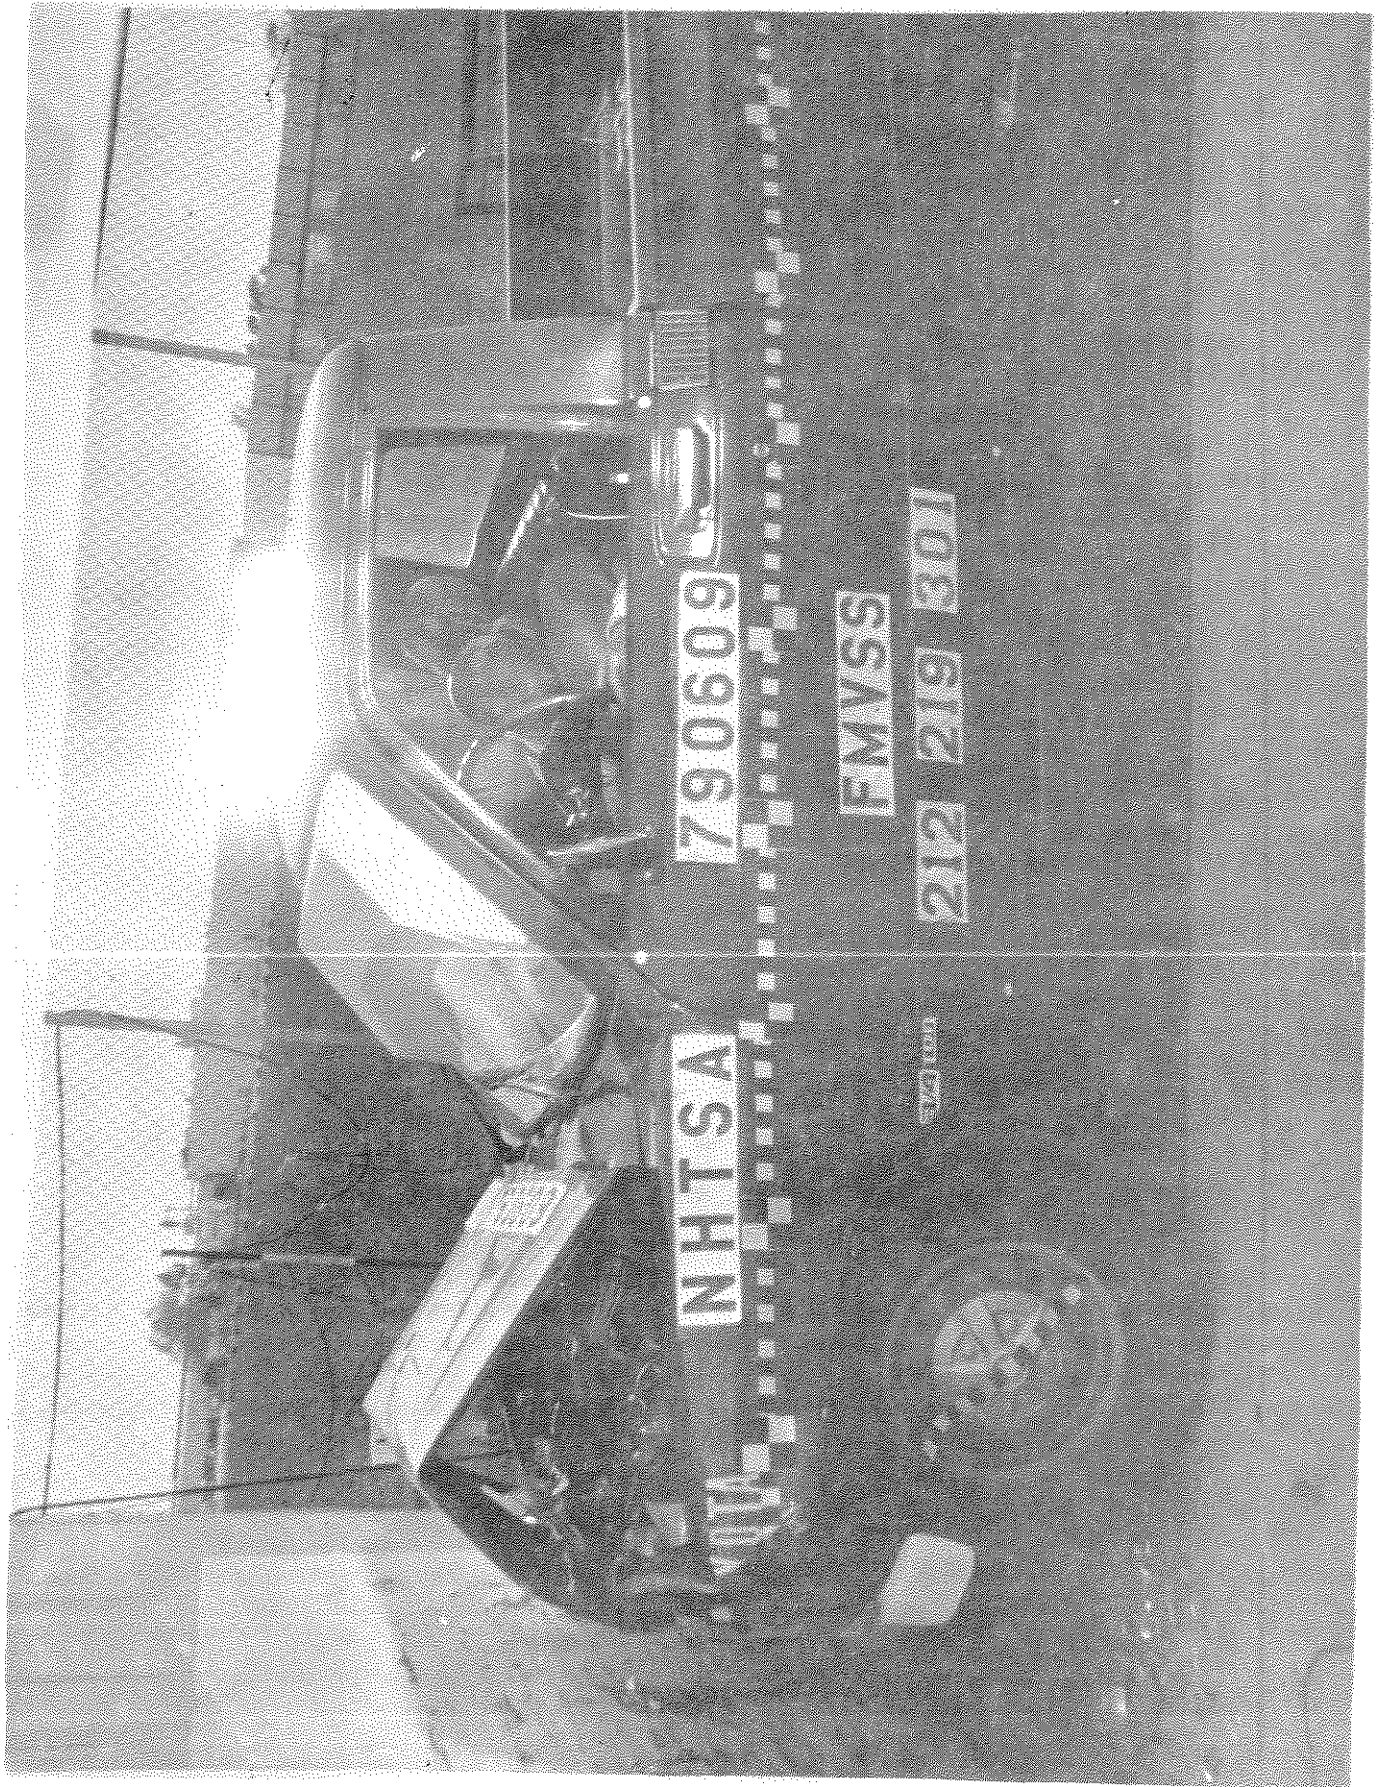
NHTSA 790609

Post-Impact, Left Side View

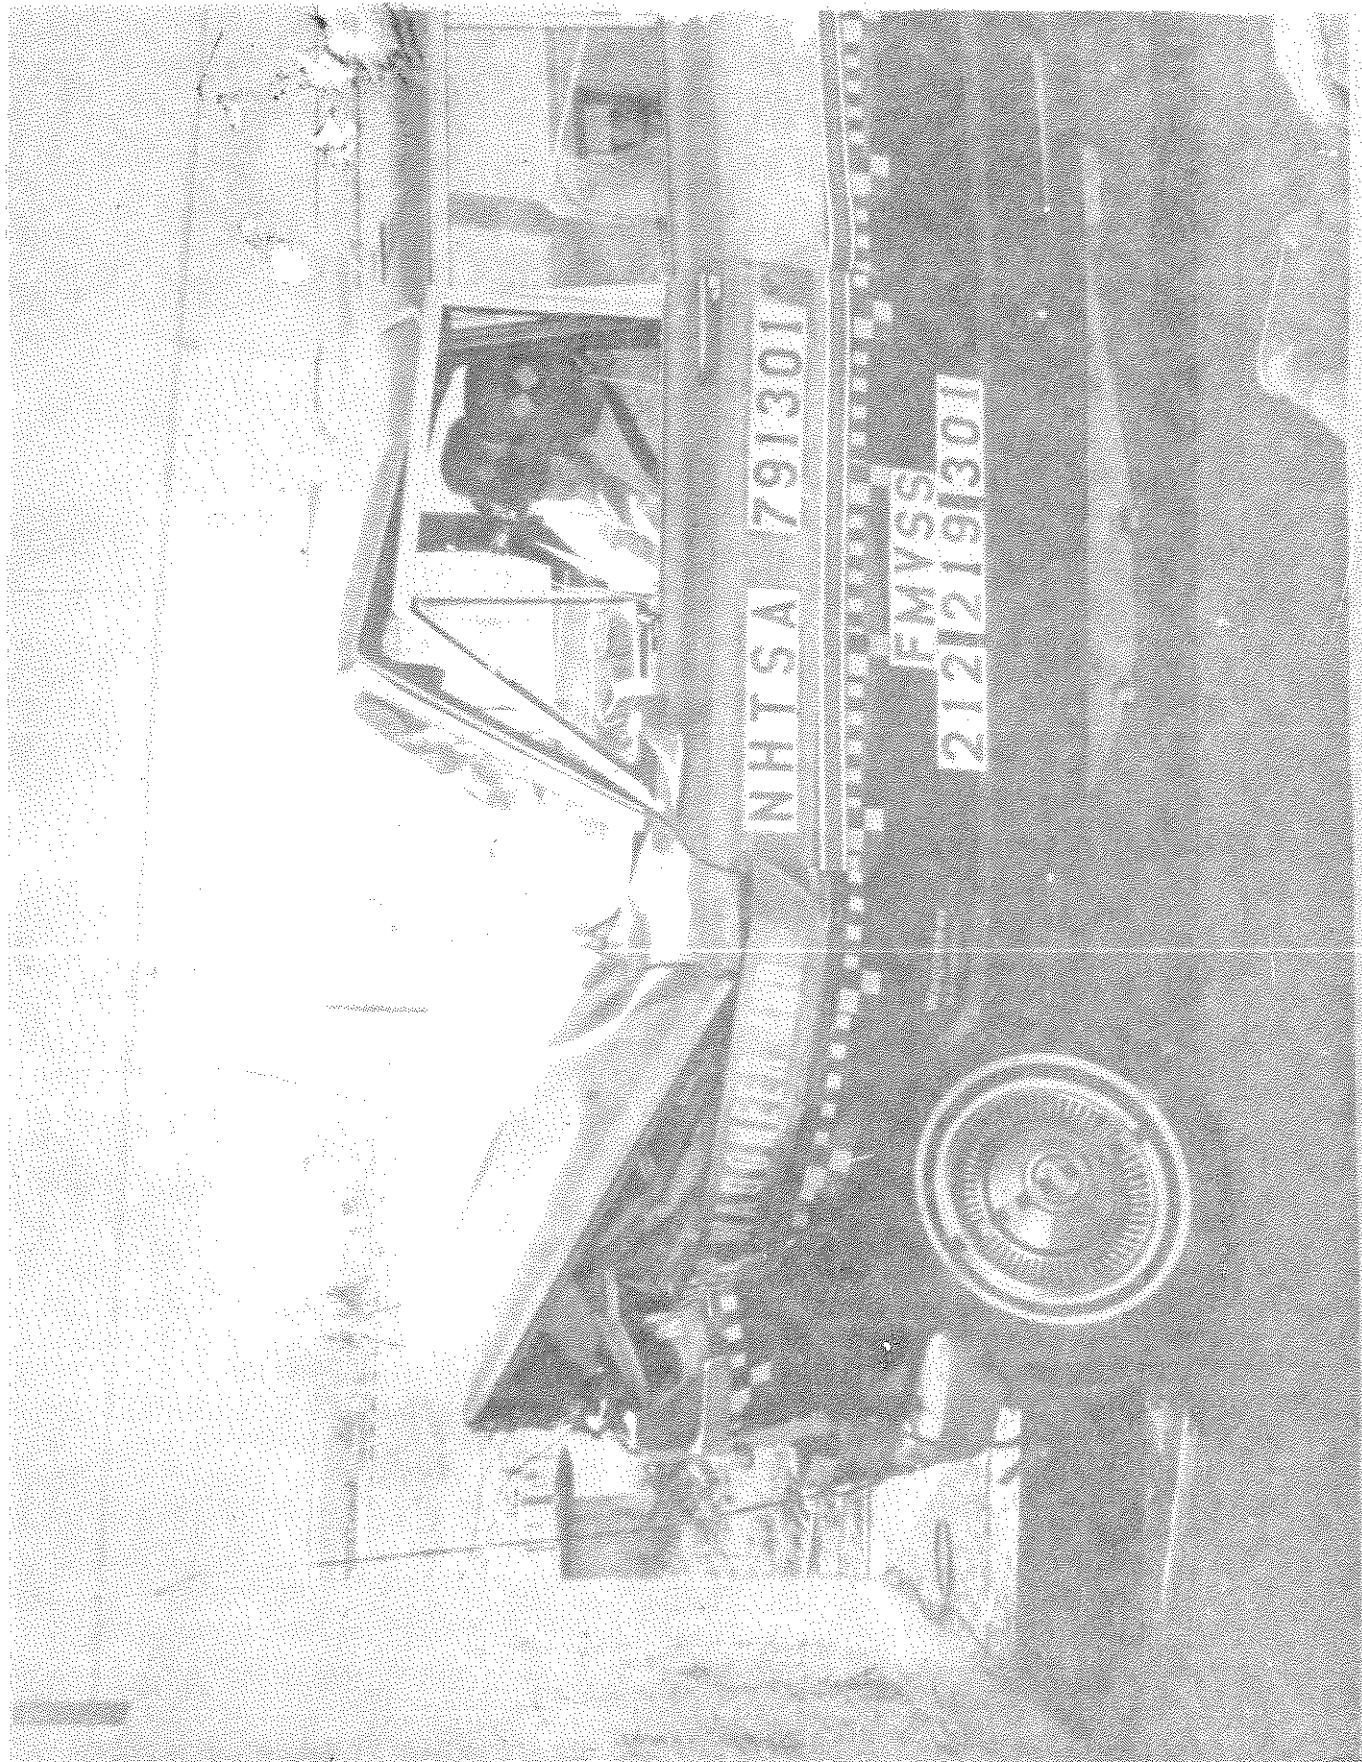
NHTSA 791301

Post-Impact, Left Side View

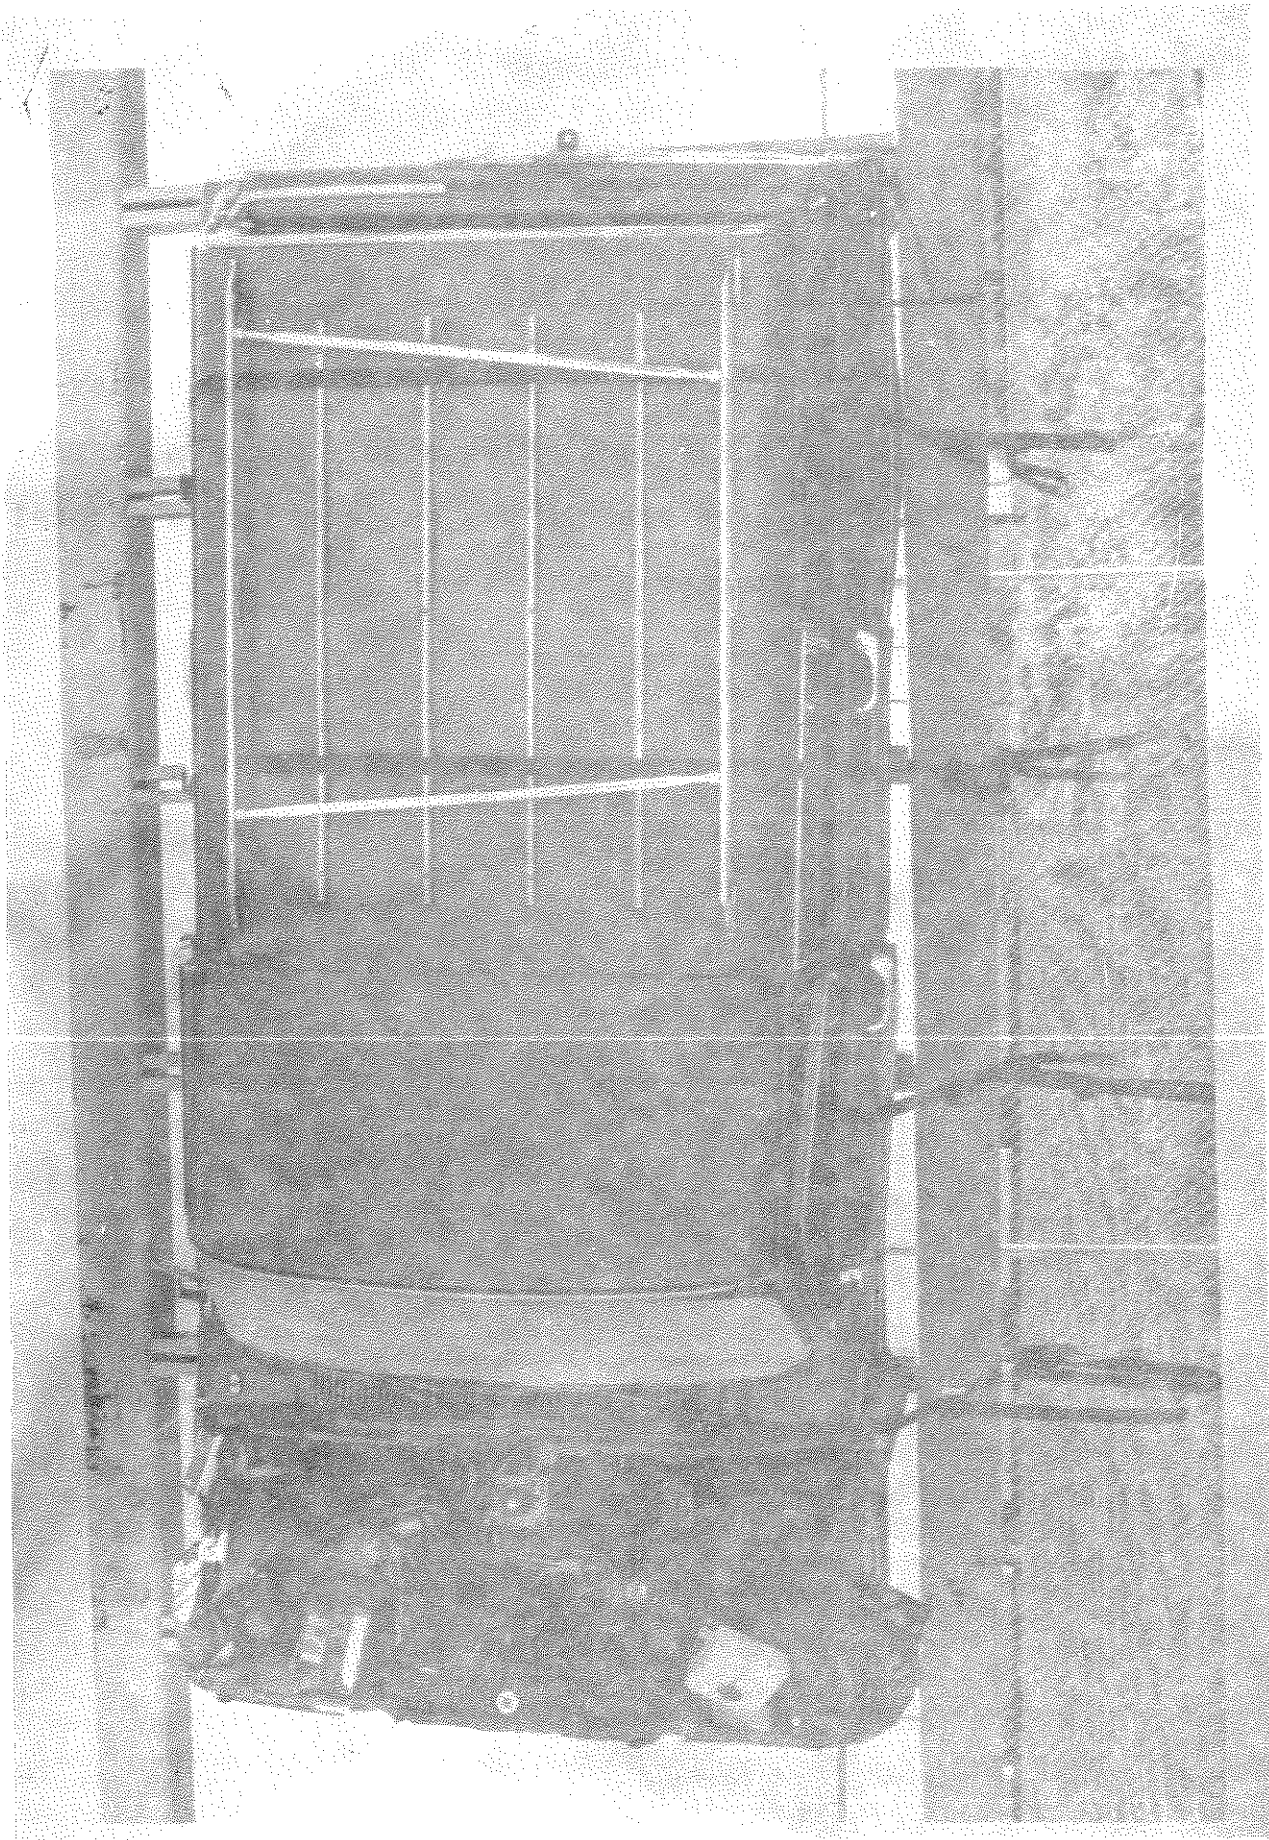
NHTSA 791301

Post-Impact, Overhead View

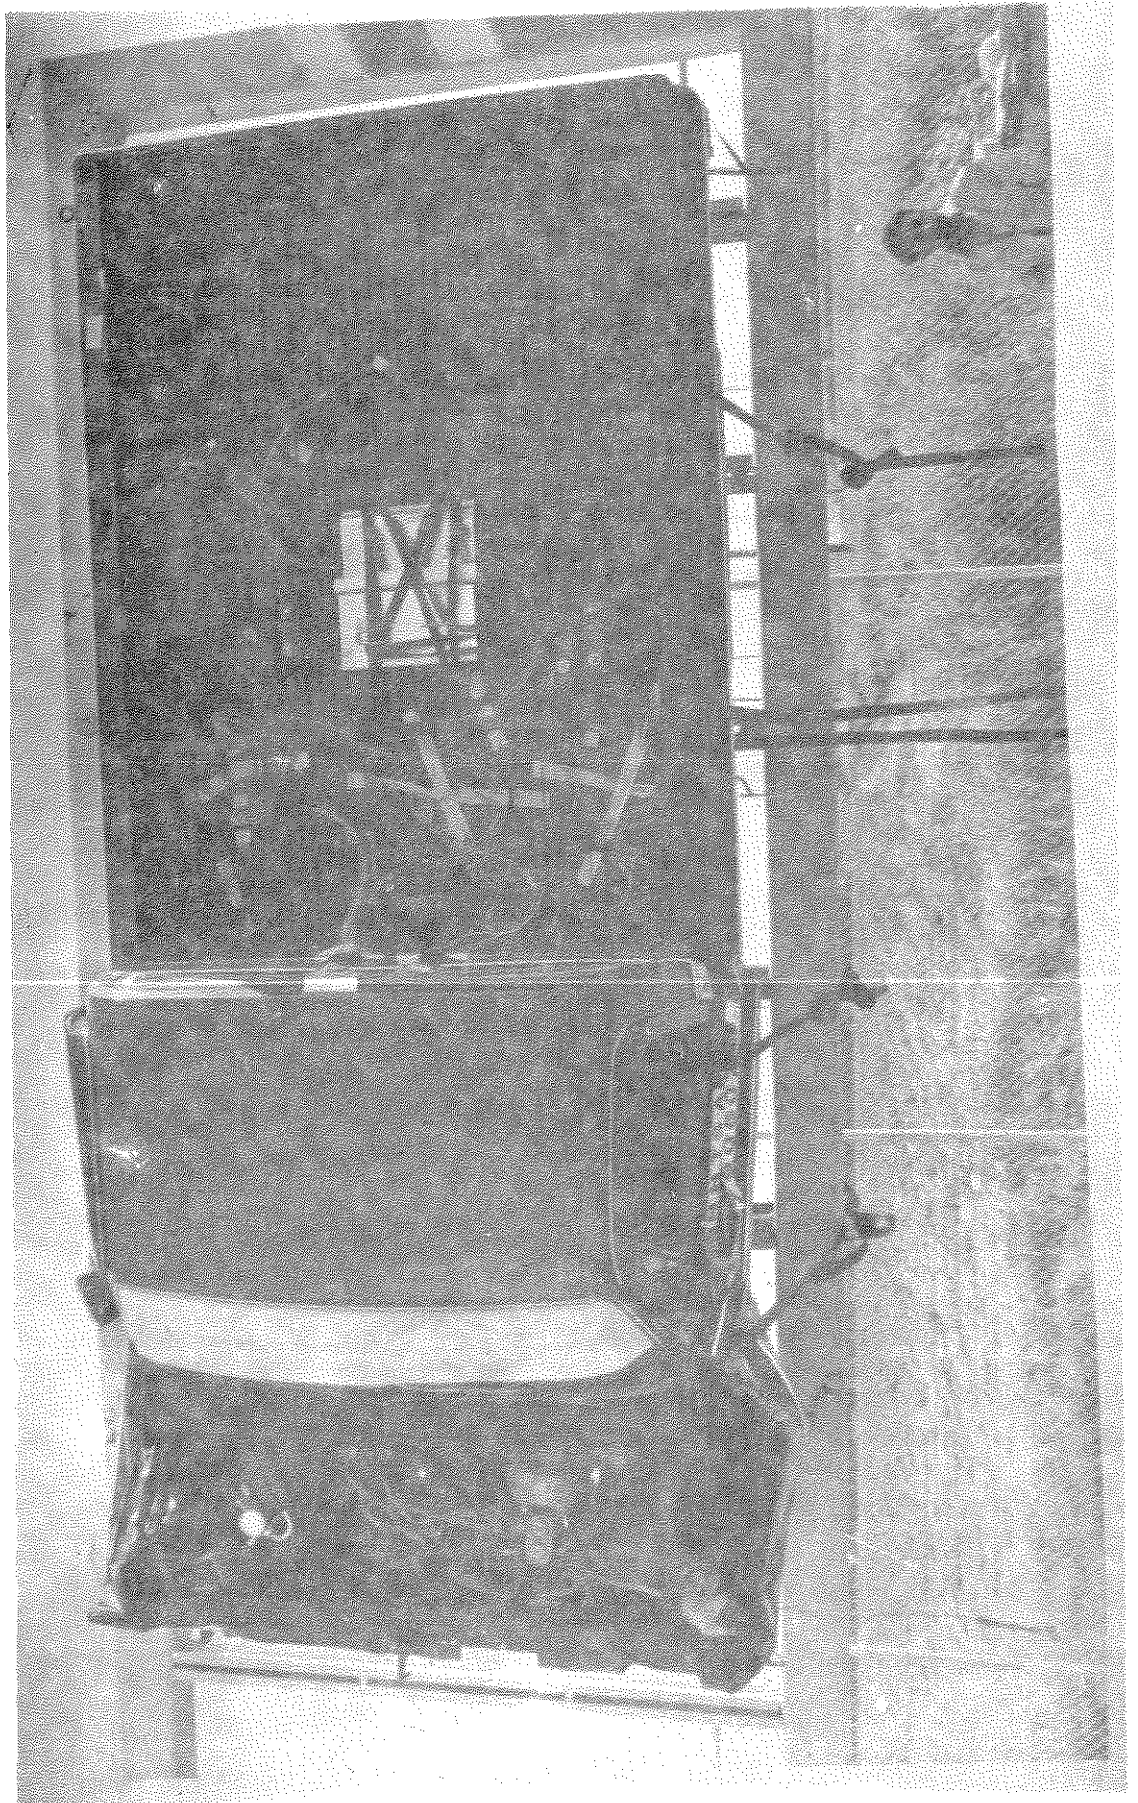
NHTSA 790607

Post-Impact, Overhead View
