**Reconstruction of Real World Frontal Impact Vehicle Collisions
Using HVE with GATB – A Case Study of Unrestrained vs.
Restrained Occupant Kinematics.**

**Justin Alexander Long, PhD BME; Emily N. Briggs, MSMS;
Clarence "Marty" Long, BSME; Siva Sai Akshay Mitnala, MBBS MS**
Ramirez & Long Forensics, Inc.
Cedar Park, TX,

**2026 HVE Forum
New Orleans, LA
March 2-6, 2026**

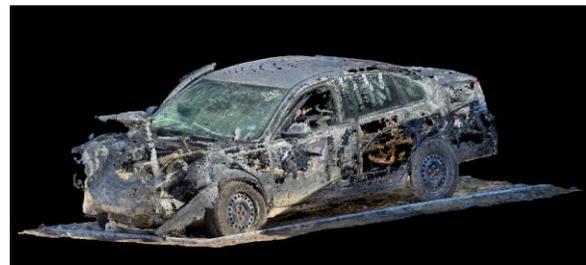
Figure 1 – Point Cloud of incident Impala damage.

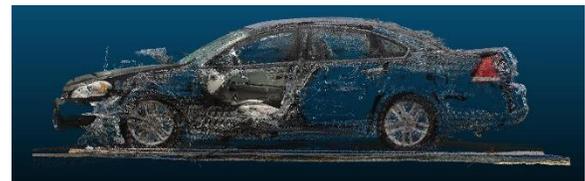
Scans of the incident Impala and a non-damaged exemplar were compared and showed no intrusion into the occupant compartment.

Figure 5 – Overlay of incident and exemplar Impala vehicles.

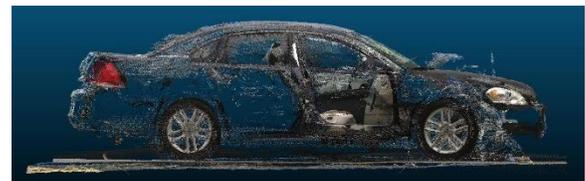
Figure 6 – Overlay of incident and exemplar Impala vehicles.

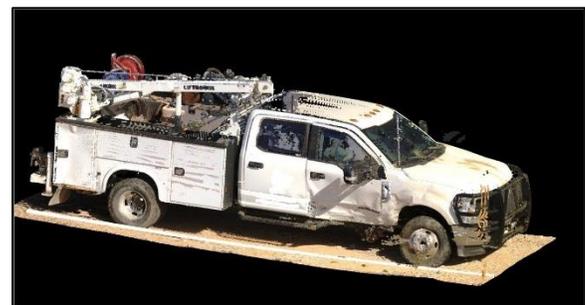
Figure 7 – Point Cloud of incident F-350 damage.

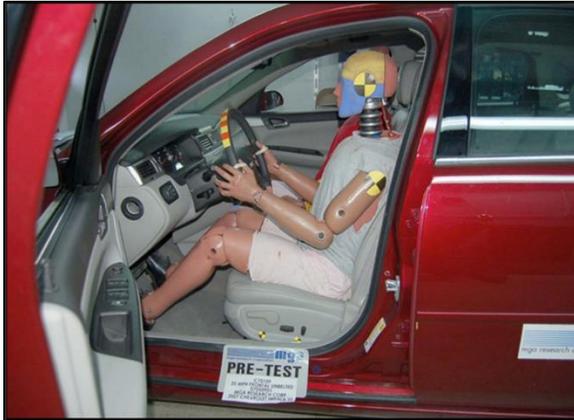
Figure 18 – Unrestrained Driver pre-test [NHTSA Report No. 208-MGA-2007-004].

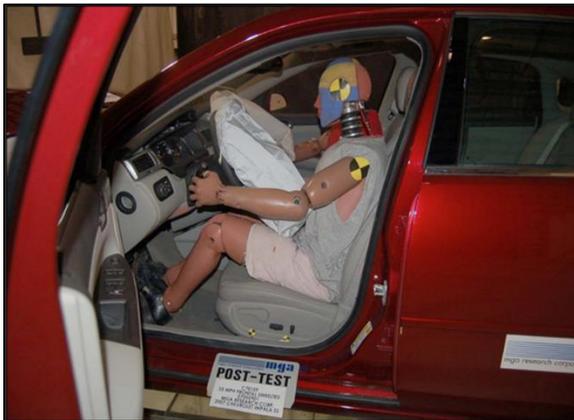
Figure 19 – Unrestrained Driver post-test [NHTSA Report No. 208-MGA-2007-004].

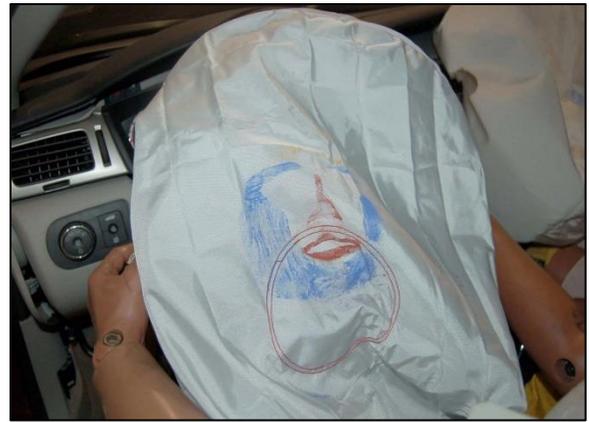
Figure 20 – Unrestrained Driver post-test airbag contact [NHTSA Report No. 208-MGA-2007-004].

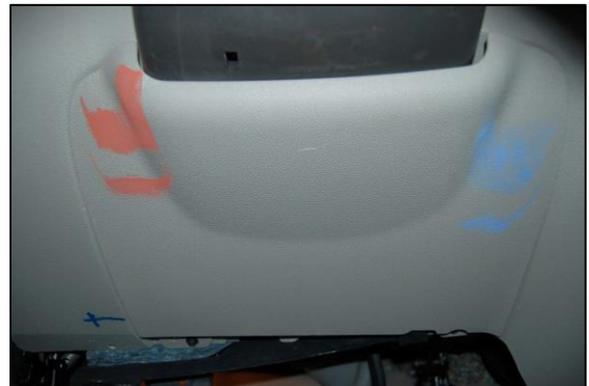
Figure 21 – Unrestrained Driver post-test showing locations of knee contact [NHTSA Report No. 208-MGA-2007-004].

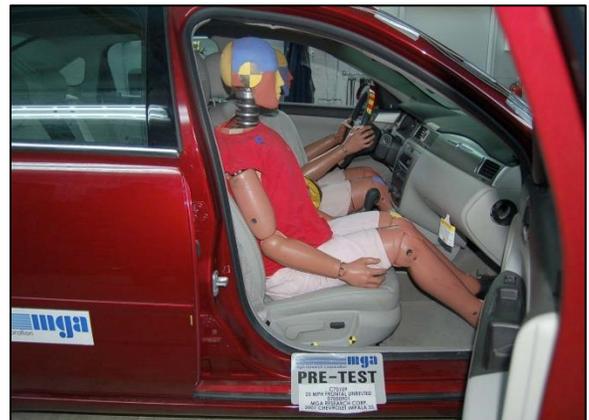
Figure 22 – Unrestrained passenger pre-test [NHTSA Report No. 208-MGA-2007-004].

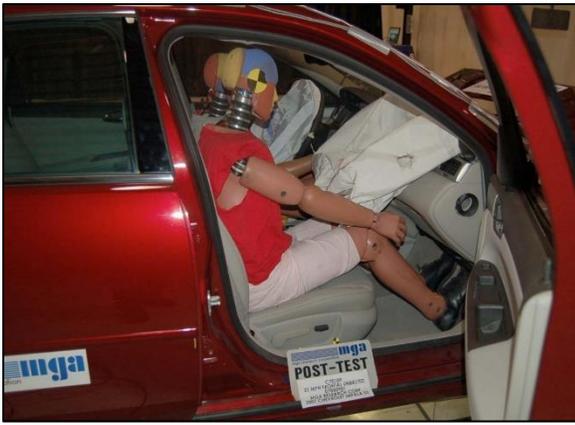
Figure 23 – Unrestrained passenger post-test [NHTSA Report No. 208-MGA-2007-004].

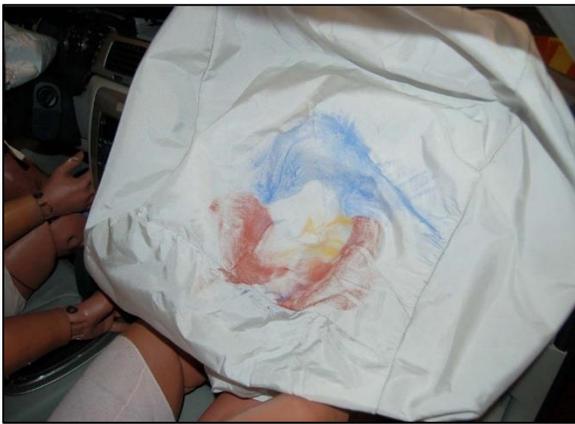
Figure 24 – Unrestrained passenger post-test airbag contact [NHTSA Report No. 208-MGA-2007-004].

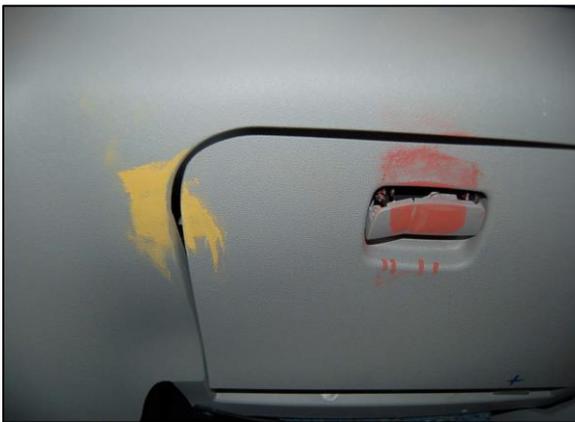
Figure 25 – Unrestrained passenger post-test showing locations of knee contact [NHTSA Report No. 208-MGA-2007-004].
