# **Reconstruction of Real World Side Impact Vehicle Collisions Using HVE – A Case Series of Pediatric Pelvic Fracture.**

This paper describes the application of HVE software to reconstruction of a series of side impact automobile crashes resulting in pelvic fracture to pediatric case occupants. This paper compares crash dynamics, injury mechanisms and occupant kinematics from on-site crash investigations, with reconstruction of these cases using HVE.

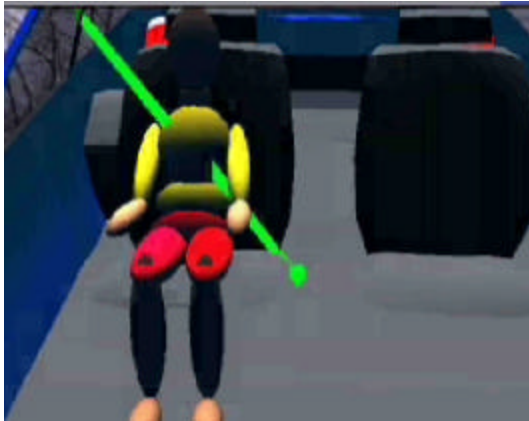
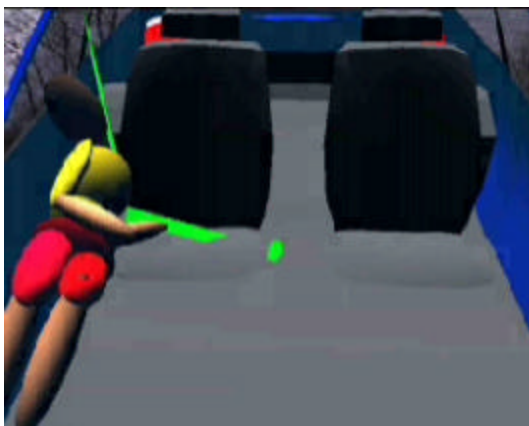
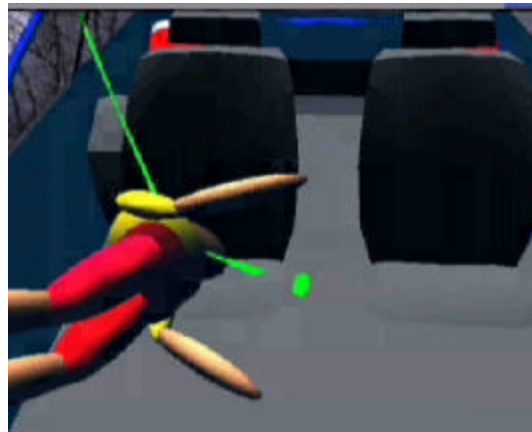
Figure 2(a): Sequential pictures of HVE occupant simulation.

The 9-year-old 50<sup>th</sup> percentile female dummy was used for 8-year-old case occupant for the simulation. The simulations demonstrated that, initially, the occupant experienced a submarining effect by slipping under the shoulder belt due to the frontal component of the impact force, then the occupant's lower torso moved right laterally towards the impact side and contacted the intruding side interior door panel. Figure 2(a) gives an illustration of the occupant movement using the GATB module of the HVE simulation. As the seat deformed due to impact the case occupant loaded her right ischium and right ilium from the base. The counterclockwise motion of the occupant due to post impact clockwise motion of the vehicle further loaded her right hip as the occupant's motion was restricted between the twisted seat back and intruding side interior door panel. A total lateral contact force of 2241.73 N was measured between side interior surface plane and pelvis of the dummy representing the case occupant.

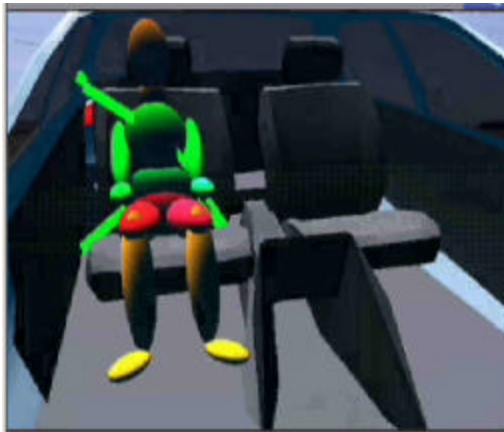
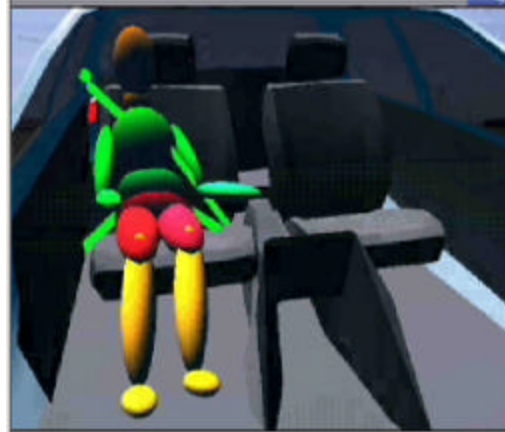
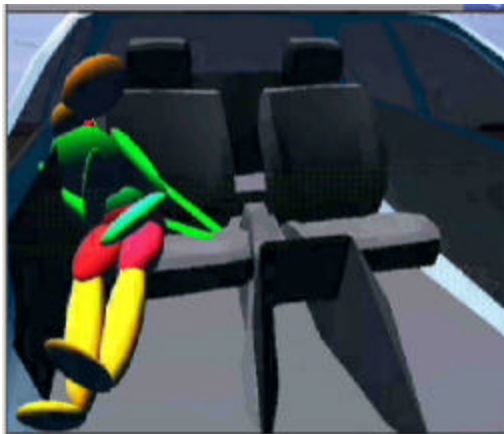
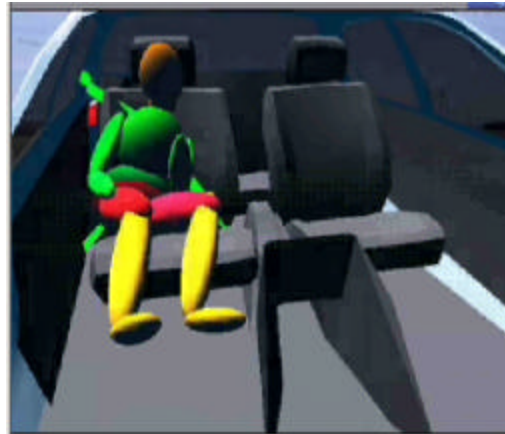
Figure 3(a): Sequential pictures of HVE occupant simulation.

A 12-year-old 50<sup>th</sup> percentile female dummy was chosen to represent the 15-year-old occupant. Figure 3(a) shows the occupant kinematics during the crash. It is observed from the GATB simulations that the occupant moved right laterally towards the impact side. The intruding right front side door interior panel (post-impact pictures) loaded the right iliac wing laterally and the right ischium from the base and from the side in an oblique fashion. The post impact clockwise motion and rollover of the vehicle further loaded the pelvis from bottom of the seat resulting. A total lateral contact force of 4416.95 N was measured between side interior surface plane and pelvis of the dummy representing the case occupant.

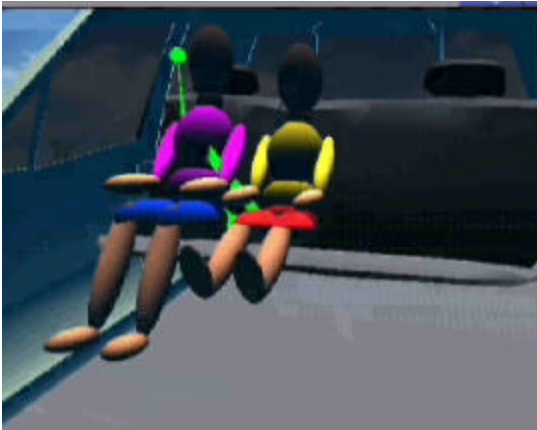
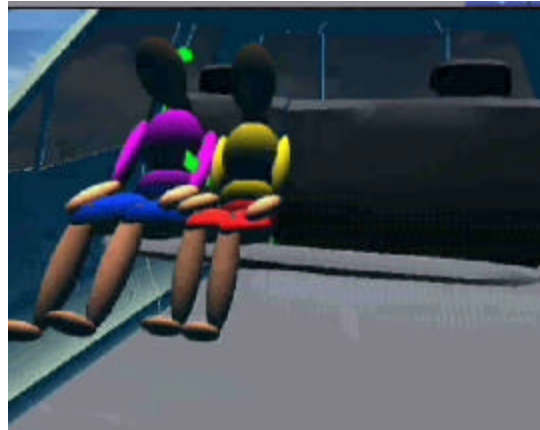
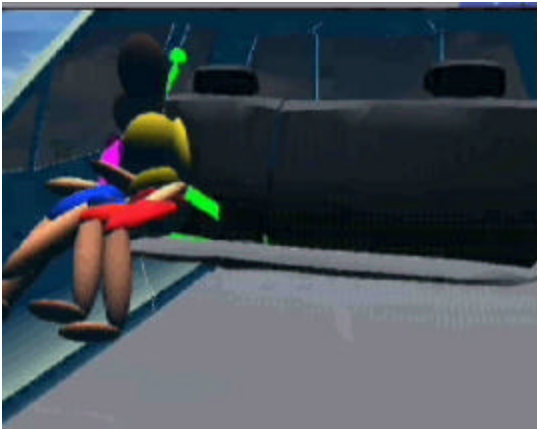
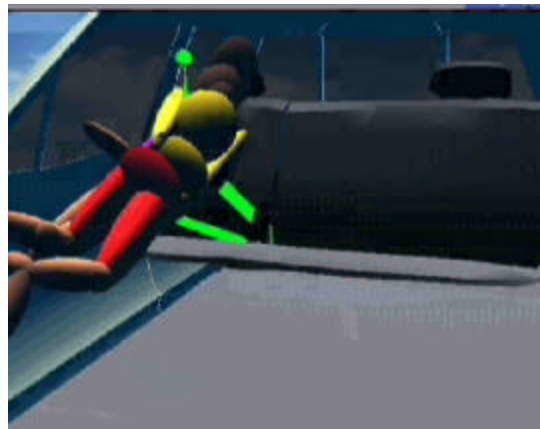
Figure 4(a): Sequential pictures of HVE occupant simulation.

The 9-year old 50<sup>th</sup> percentile female dummy was used for the 9-year-old case occupant and a 6-year old 50<sup>th</sup> percentile dummy represented the 6-year-old occupant. Due to the limitation of the restraint capability in the HVE, only the case occupant was restrained and the other occupant was unrestrained in the simulation. The simulation results shown in the figure 4(a) demonstrate that the case occupant seated near the right side door moved right laterally towards the impact side and loaded the greater trochanter of the right femur bone and the right iliac wing through the intruding right side interior door panel with protruded armrest. The other occupant seated on the left side on the same seat further loaded the case occupant's left hip from left side. A total lateral contact force of 1766.74 N was measured between side interior surface plane and pelvis of the dummy representing the case occupant.

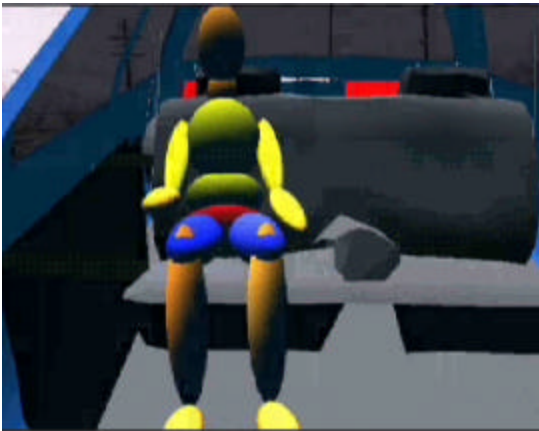
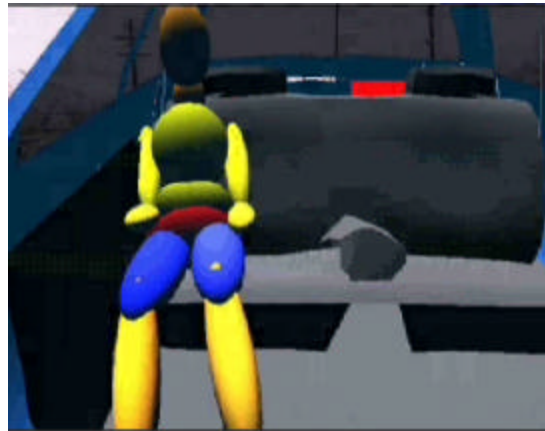
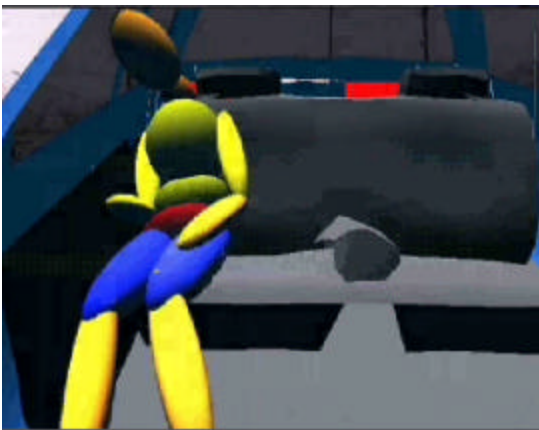
Figure 5(a): Sequential pictures of HVE occupant simulation.

The GATB simulation of the case occupant kinematics is shown in the figure 5(a). It can be seen from the sequence of the simulation pictures that as the case occupant impact her

right side of the hip and rotated in a clockwise motion due to post impact motion of the vehicle she further loaded the posterior end of the pelvis through left side armrest. The simulation demonstrated a significant head contact with side window glass in the simulation, but the crash investigation reported that the occupant had no head injuries. It was later observed that before the head reached the window, there is a likelihood of glass shattering. A total lateral contact force of 1857.63 N was measured between side interior surface plane and pelvis of the dummy representing the case occupant.

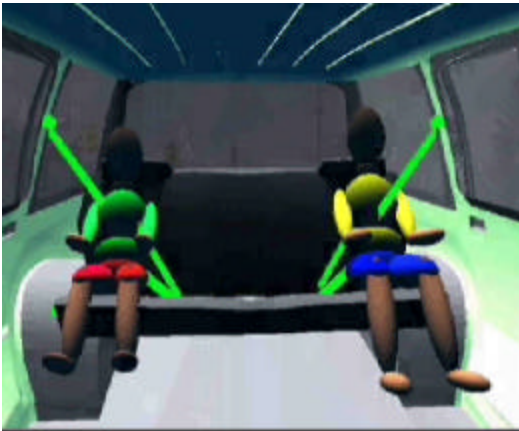
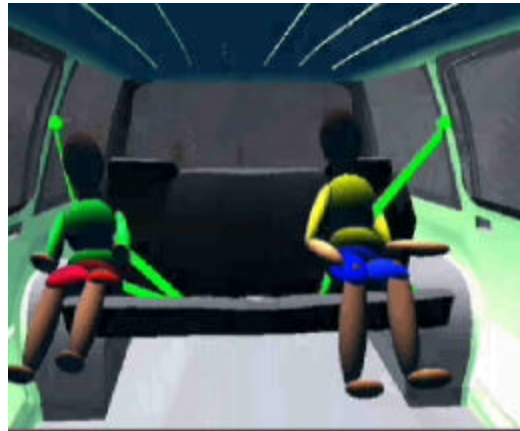
Figure 6(a): Sequential pictures of HVE occupant simulation.

The 8-year-old male case occupant was represented by a 9 yr-old 50<sup>th</sup> percentile dummy and 5-year-old by a 6-year old 50<sup>th</sup> percentile dummy. Figure 6(a) shows the sequence of pictures of the occupant simulation obtained from GATB. It is seen that the case occupant moved right laterally towards the impact. The greater trochanter of right femur bone and the right iliac wing contacted the intruding right rear door interior panel with protruded armrest. A total contact force of 2003.46 N was measured between side interior surface plane and pelvis of the dummy representing the case occupant.

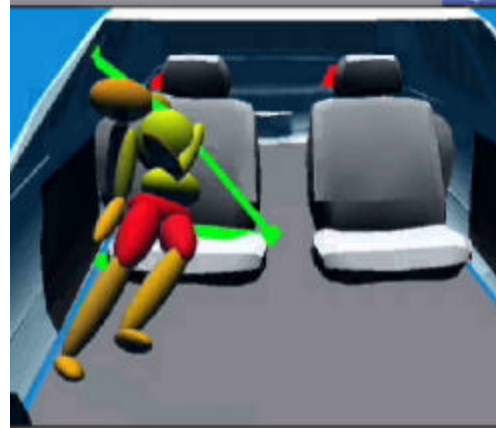
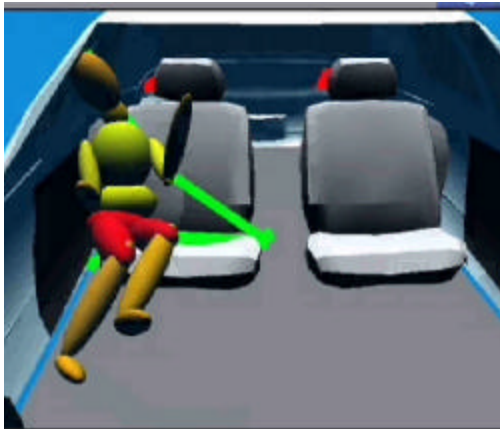
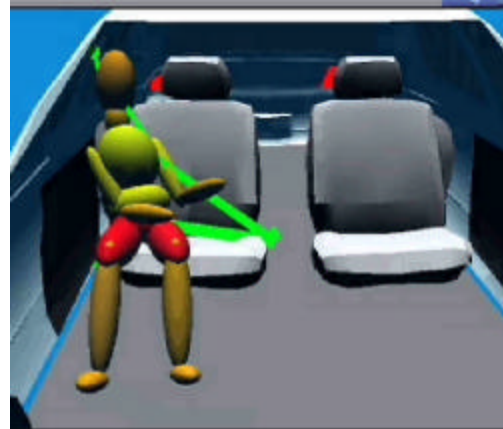
Figure 7(a): Sequential pictures of HVE occupant simulation.

Figure 7(a) shows the sequence of the occupant kinematics during the crash. A 12-year old male 50<sup>th</sup> percentile dummy represented the 13-year-old male occupant. The simulation demonstrated that the case occupant's pelvis moved towards the impact. The right front seat, due to B-pillar and the floor panel intrusion, loaded the hip from side and base. The injuries that were contralateral to the applied force suggest that the pelvis rotated so that the load path minimized the loads on the right pelvis. Based on three iterative simulations by placing the side interior contact plane at different position based on intrusion values, it could be observed that the occupant's hip was held by a loose lap portion of the belt, which

resulted in considerable pelvic rotation during the crash. It was observed that the lateral contact force of 366.68 N was relatively less when compared to other cases. Photos from the crash investigation showed evidence of occupant contact with the protruded armrest supporting the assertion that the primary injury mechanism involved lateral loading of the hip from the intruding interior door panel with protruded armrest.
