# Vehicle Trajectory Following Steering Disconnect Investigated by Application of HVE-VSM Steering DOF Capability

**William Blythe**  
Consulting Engineer

## ABSTRACT

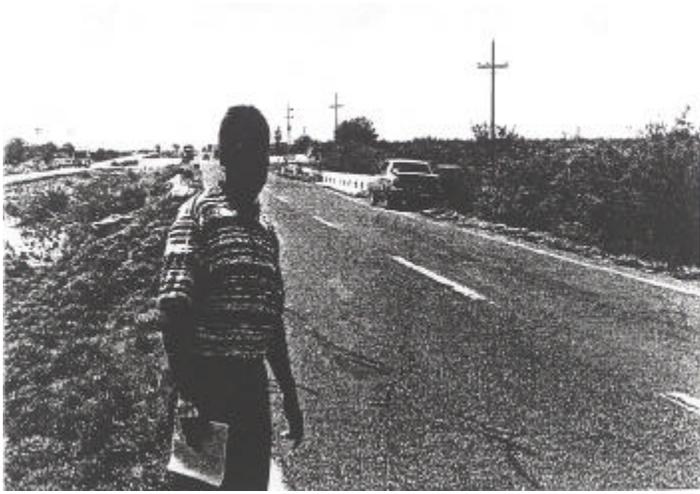
Figure Two

Many months after the accident, the investigating police officer was taken to the site of the accident where he described generally the location and path of the marks and the resting area of the vehicle. Figures two, three and four show the general area.

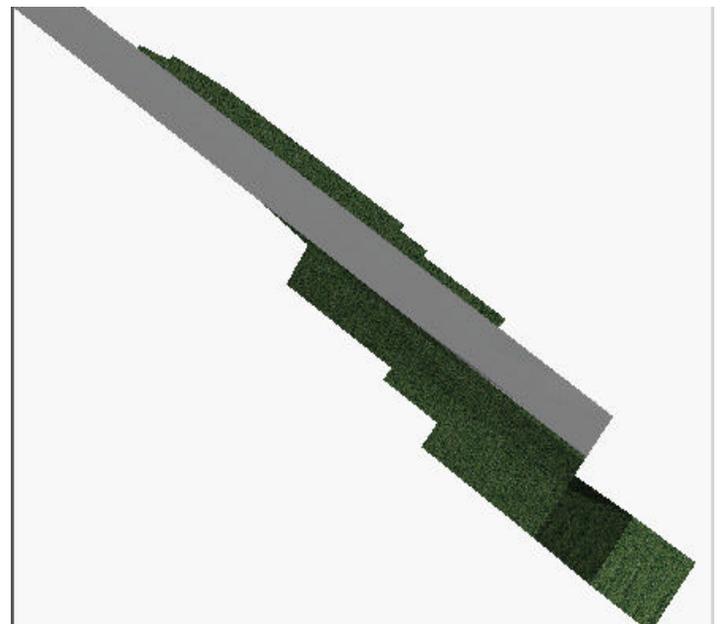
Figure Eight

With some considerable difficulty, an acceptable topographic map was obtained through a licensed Mexican surveyor. The terrain was constructed in the HVE 3-D Editor point by point. An overhead view of a portion of the terrain is shown in Figure Eight.

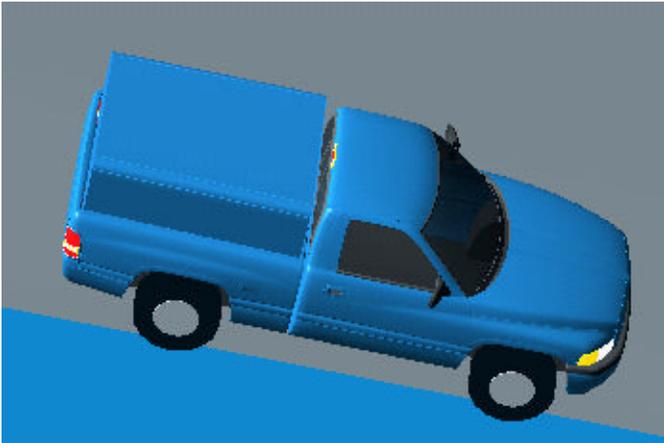
Figure Nine

A vehicle model was produced by EDC and is shown in Figure Nine. All mechanical properties were checked independently against manufacturer's specifications.

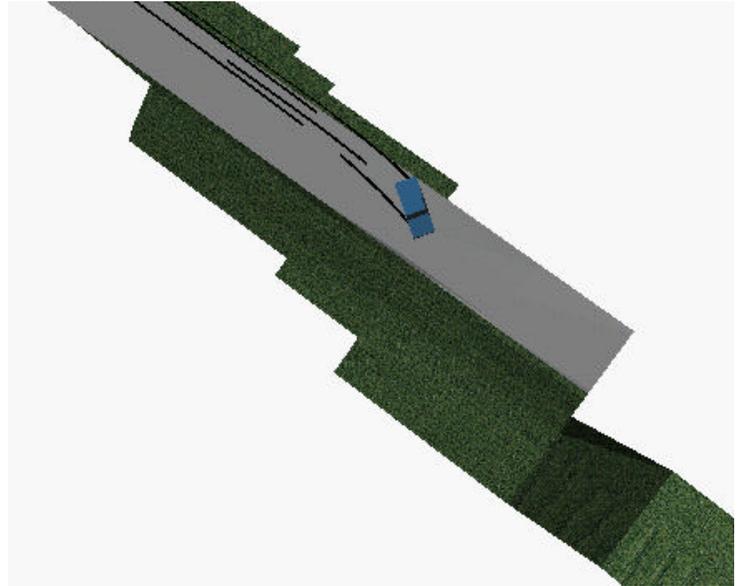
Figure Eleven: t = 4.7 sec.

Figures ten through fourteen show one solution.

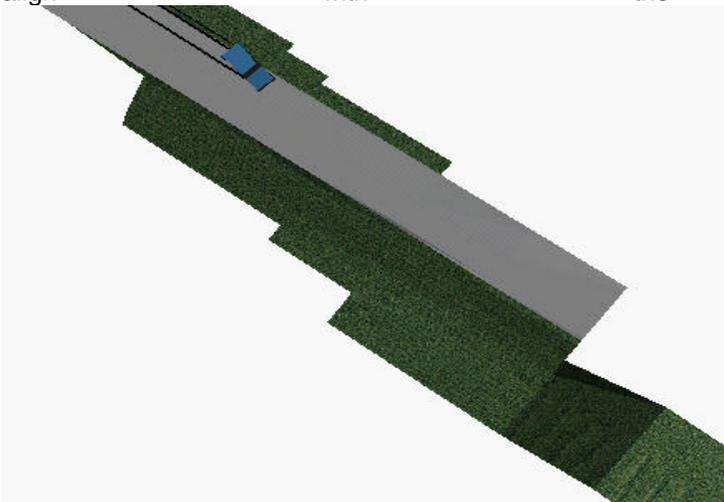
Figure Ten: t = 3.3 sec.

With the steering DOF calculation mode activated, runs were made with various initial speeds, starting positions, and braking patterns. It became evident that (1) initially the vehicle would drift to the left, due to the super-elevation of the number one, or left, lane, (2) brake application while the left-side tires were on the grass of the median (with an assumed, low friction coefficient compared to that of the road surface) would cause a clockwise yaw back onto the road, and (3) release of the brakes while on the road would allow the front wheels to align with the
