Validation of Collision Reconstruction Opinion Utilizing EDSMAC4

Steven Day
California Highway Patrol

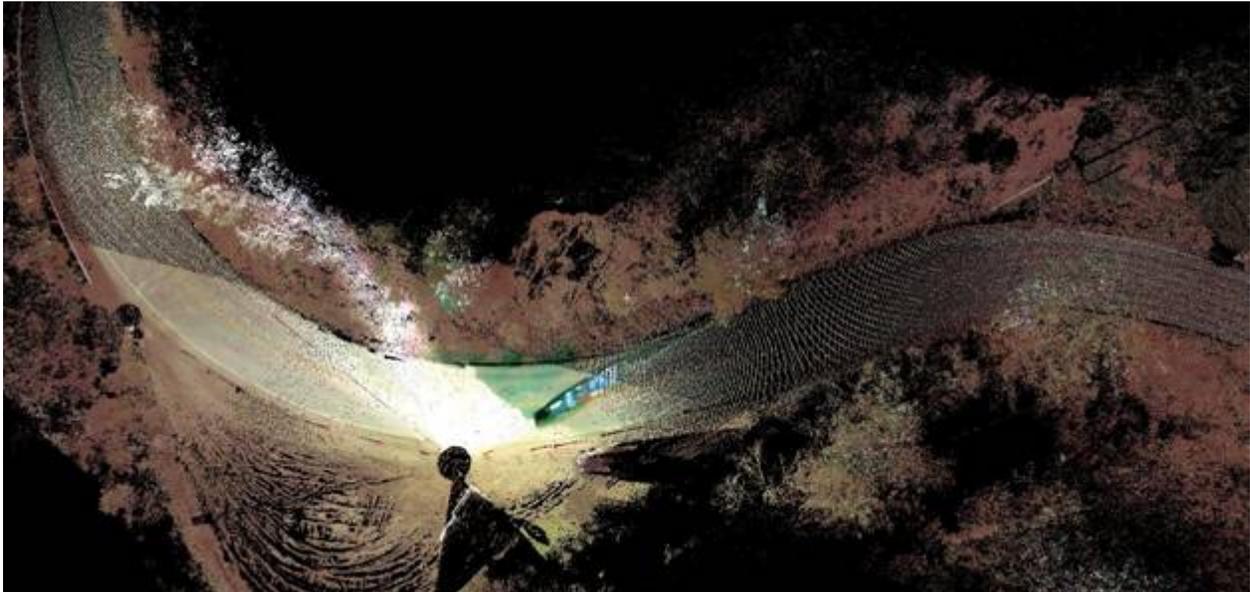
Figure 4: *Leica ScanStation HDS 3600 scan of the collision site*

Definition Surveying (HDS) instrument to scan the collision site characteristics in three dimensions. The scanner obtained clouds of points that represent the true position of points of contact where the laser pulse struck various environmental objects. The point clouds represent the shape and position of the objects scanned relative to the position of the scanner. Three scans (each with multiple clouds of data) of the collision site were conducted acquiring nearly 14 million additional points. The clouds of points were registered (re-sectioned) to the original survey data via the reference nails (Figure 4).
