Predicting and Analyzing Vehicle Dynamics in a Train-Passenger Vehicle Collision Using EDSMAC

James S. Sobek and William E. Dickinson
Wolf Technical Services, Inc.

ABSTRACT

This paper describes the successful application of EDSMAC to “pre-construct” a staged car/train collision. The paper compares the real-world results of that April 1996 collision with the EDSMAC predictions and with a recent re-analysis of the collision using the HVE system and the current EDSMAC4 program.

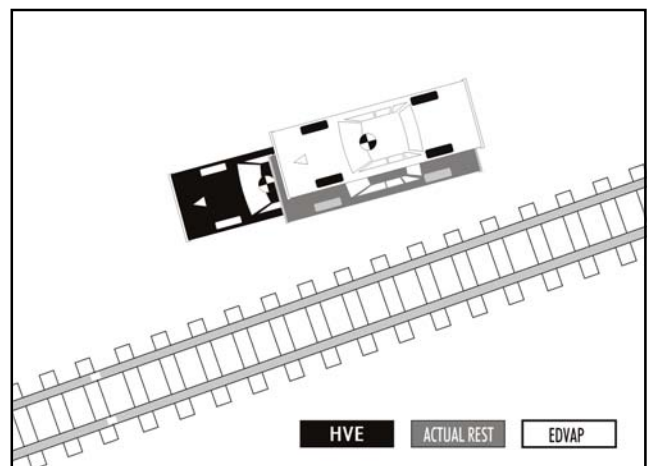
The HVE EDSMAC4 analysis predicted the car would travel about 109 feet north and 8 feet west, with a locomotive impact speed of 25 miles per hour.

Figure 6. EDVAP, HVE & Actual Rest Positions
